# HERITAGE CONSERVATION OF RELIGIOUS COMPLEX IN MANDALAY CITY, MYANMAR

MISS MYAT SOE PHYU

Department of Architecture, Mandalay Technological University,  
Mandalay, Myanmar  
[myatsoephyu@gmail.com](mailto:myatsoephyu@gmail.com)

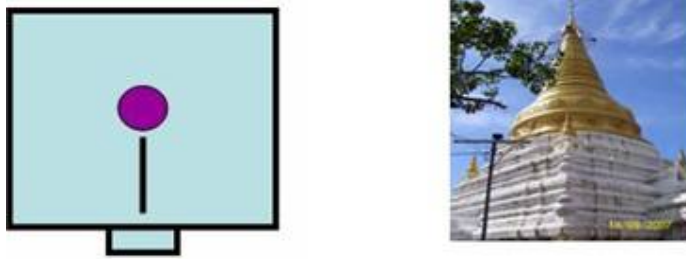
Fig.5 Grade 4(Faungdawoo Stupa)

Fig.5 shows the site composition of Grade 4 type. Site area is situated with one entrance and surrounded by one enclosure walls. Stupa is located at the center of site. Site area is small and not complete with the religious factors. Sample site is Faungdawoo Stupa site. See Fig.5. The religious compounds which are described as Grade 1 are Kuthodaw stupa and Mahamuni pagoda, Grade 2 are Sandamuni temple and Mahasularmuni pagoda and others are Grade 3 and 4.

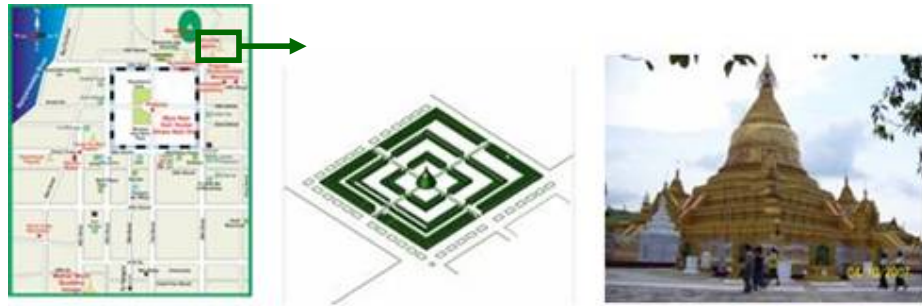
Fig.6 Kuthodaw Site

(a)Location

(b) isometric form

(c)kuthodaw stupa

The World's biggest book(stone inscriptions of pitaka) located within the three enclosure walls of this compound. The stone inscriptions are made of marble. Being marble, it remains as good as new after passing more than a century. Also king Mindon believed that this stone copy of Pitaka will last as long as the world exists. The stone inscription in the complex has same function, form and color.

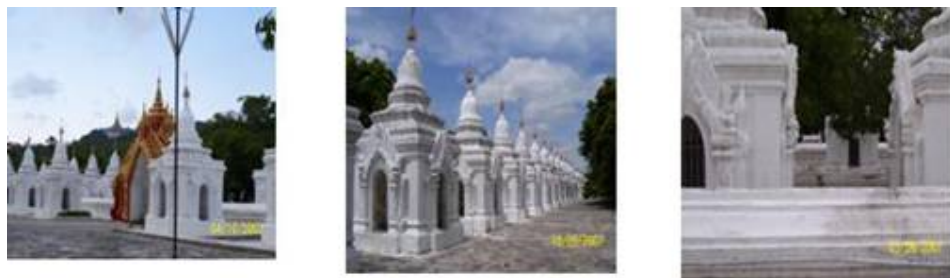
Fig.7 (a) stone inscriptions within each shelter located in three enclosure walls

It is the ancient site which is required to be protected and preserved by its historical, cultural and artistical value. It is embodied in the site itself, its fabric and its structure. It is ancient site that had existed in 1862. It had been determined as cultural heritage by the protection and preservation of cultural heritage region law. In this site there are architectural structures and stupa,

stone inscriptions and records. This site is located with three enclosure walls and there are (729) numbers of stone inscriptions and records in these walls. This site is located in the ancient site zone and protected and preserved zone.

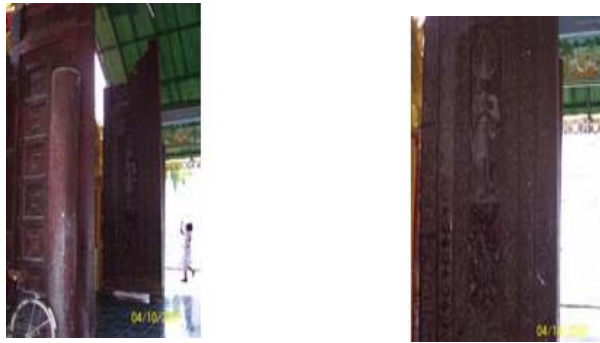
Fig.7 (b) Significance of Entrance Doors

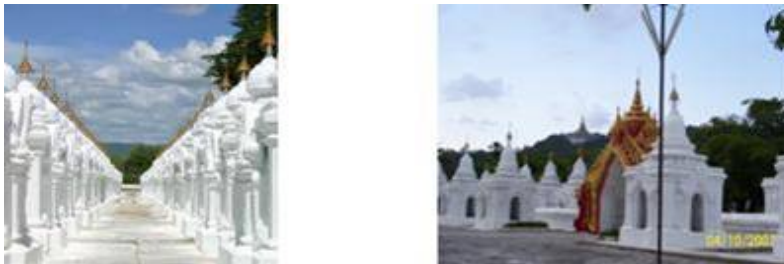
Fig.8 Harmony and deference

**Location of Dominant Structures**, their structures of stone inscription were planned to be in central or axial position and in nature to express their importance

**Harmony between Nature and the Structure**- In Kuthodaw Pagoda, the whole complex is in harmony and unity with respect to the distance and height and the whole complex is in harmony with the nature of its environment, Mandalay Hill.

**Deference between Nature and the Structure**- Kuthodaw stupa is giving deference with respect to each other and Mandalay hill. Moreover, the structures of stone inscriptions give deference with one another and site.

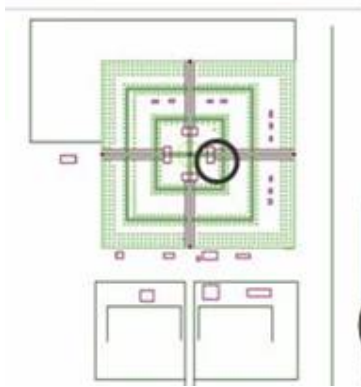
In the present day, many donors donated the buildings for the pilgrims in this religious complex. Their structure obstructs the view to the Pagoda due to their height location and distance. Moreover, they obstruct the ancient historic effect of site with their different structures and color as shown in figure (11) and (12) below. Therefore, it is very important to preserve the setting of site. In this site, it is strongly stated that Conservation requires the retention of an appropriate visual setting and other relationships that contribute to the cultural significance of the place.

Plan of structures which obstruct Photos which shows visual obstruction  
Fig.11 Obstruction View

New constructions, demolition, intrusions or other changes which would adversely affect the setting or relationships are not appropriate. Therefore, the new constructions should not be allowed and then the site should be restored its ancient characters and affects such as form an color. Moreover, the valuable paintings and sculptures should be made to retain their original value as much as possible. Therefore, the painting of moats should be replaced to the original color to retain original value. Certain precautions must be taken against damage.

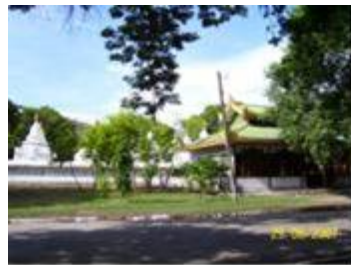
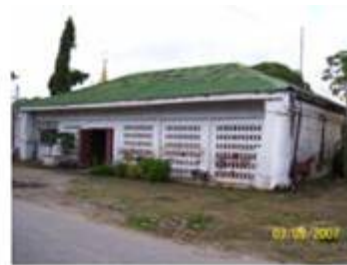
Fig.13 Reconstruction Case

(a) New structure

(b) original rest house

In fig. 13 (a), it is a new structure and it is a new construction at the present day. Fig.13 (b) is the last original rest house. It is necessary to reconstruct the missing parts of historic site to retain the original value. When the new reconstructed parts are designed, they must be harmonized with the original building.
