# PYANJ RIVER MORPHOLOGY AND FLOOD PROTECTION

July 2014

## ADB CENTRAL AND WEST ASIA WORKING PAPER SERIES

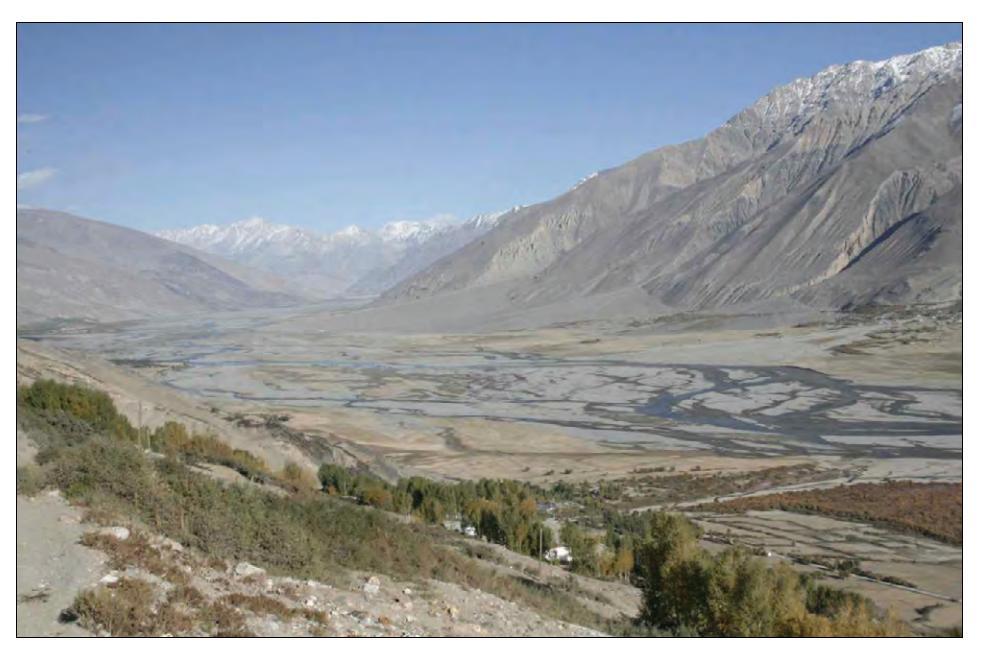
Figure 2: Braided section of the Pyanj River in the Upper Basin. Source: Getinsa Ingenieria.

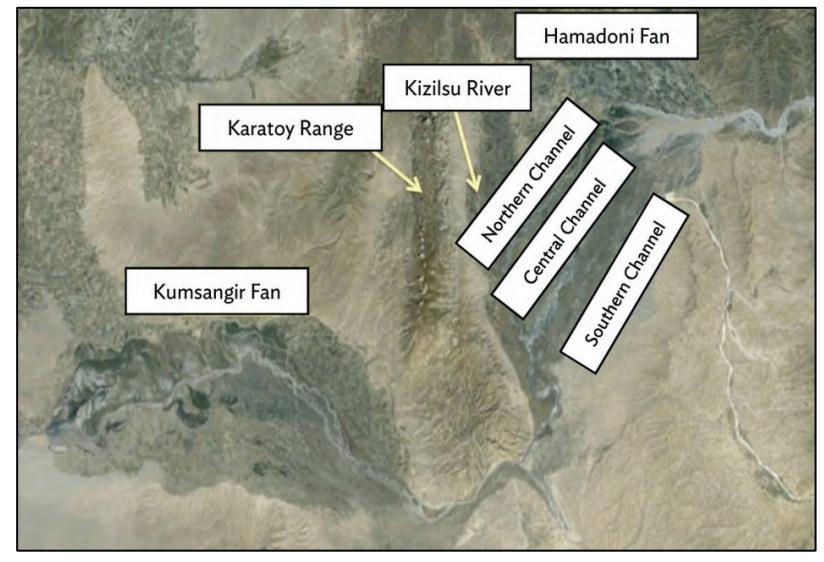
Figure 3: The Lower Basin of the Pyanj River. Source: Google Earth.

The Lower Basin 5. is characterized by two distinct fan-shaped depressions that are surrounded by bedrock uplands and constricted at their downstream ends (Figure 3). The Karatoy Range separates the two lowland depressions. The upstream depression is referred to as the Hamadoni Fan and the downstream depression as the Kumsangir Fan, so named for significant Tajikistan settlements in each area. The Hamadoni Fan is formed where the river first emerges from the more confined Upper Basin and is characterized by three main flow paths on the southern half of the fan, referred

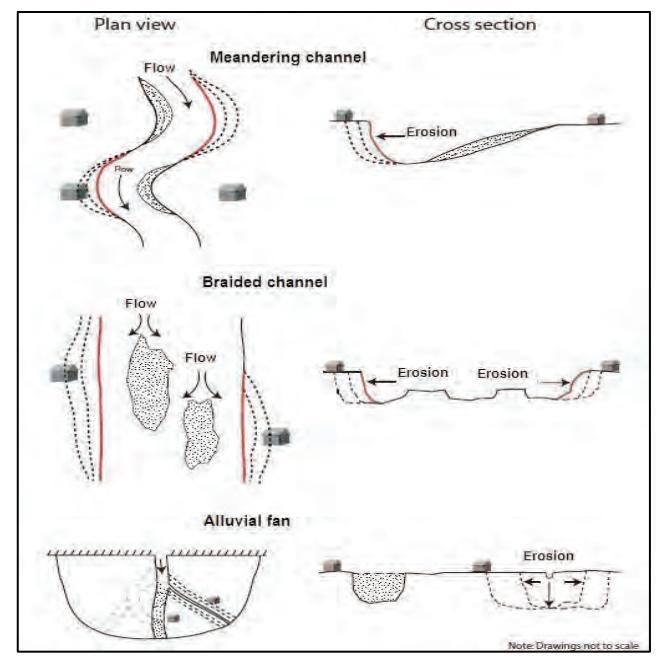
Figure 4: Comparison of meandering channels, braided channels, and alluvial fans in terms of the location and character of erosion. Source: Getinsa Ingenieria.

6. Three basic channel types are present in the Pyanj River Basin and, more broadly, throughout Asia: meandering channels, braided channels, and alluvial fans (Figure 4). The variations in channel type are largely a function of channel gradient, valley confinement, and particle size. Distinct fluvial processes and channel patterns characterize the three channel types. Identifying the dominant channel pattern in a given area provides clues to the types and severity of flood hazards present and the most appropriate flood management strategies to implement. The following description of the three basic channel types is drawn from published literature and illustrated with observations from the Pyanj River Basin.

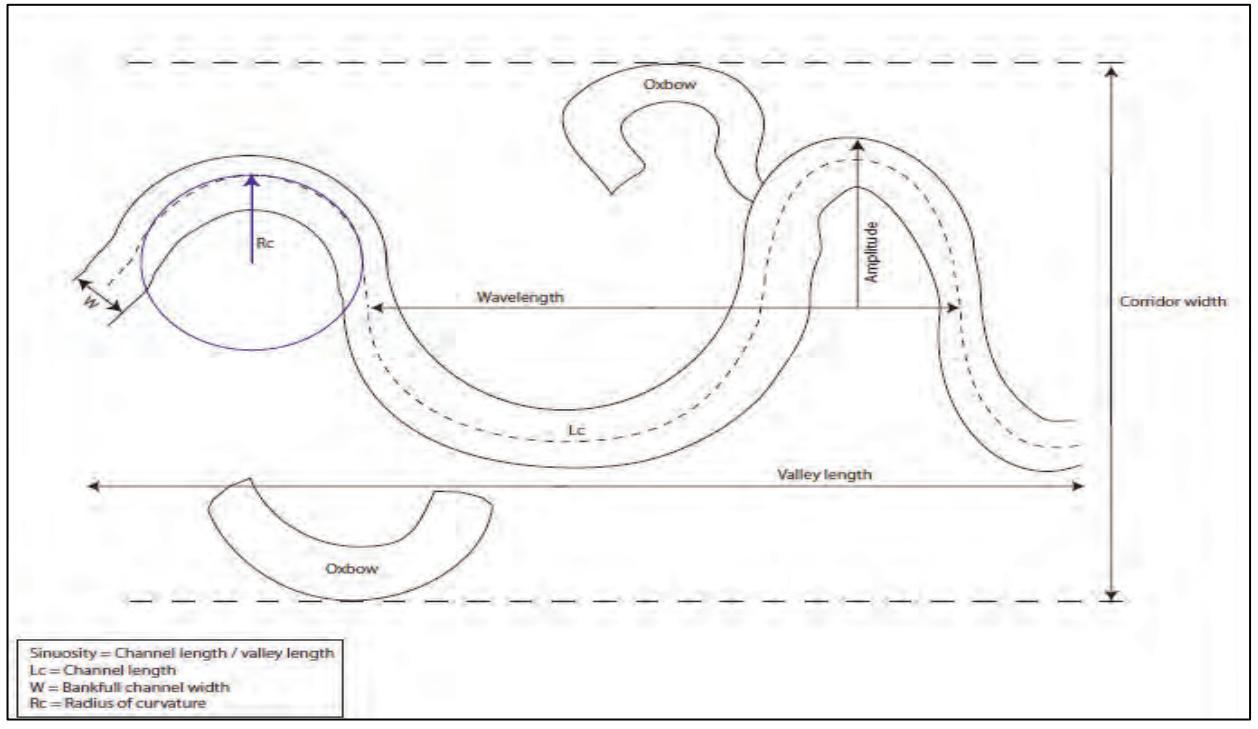
Figure 5: Definition of meandering planform characteristics. Source: Getinsa Ingenieria.

11. Empirical studies of meander geometry show the radius of curvature of meander bends is generally 2.4 times the bankfull channel width (Garcia 2008), implying this is an equilibrium dimension to which meandering rivers evolve (Lagasse 2004). Numerous studies also demonstrate that the maximum bank erosion rates on meandering rivers occur in meander bends with a radius of curvature between 2 and 3 times the bankfull channel width (Begin 1981, Nanson and Hickin 1986,

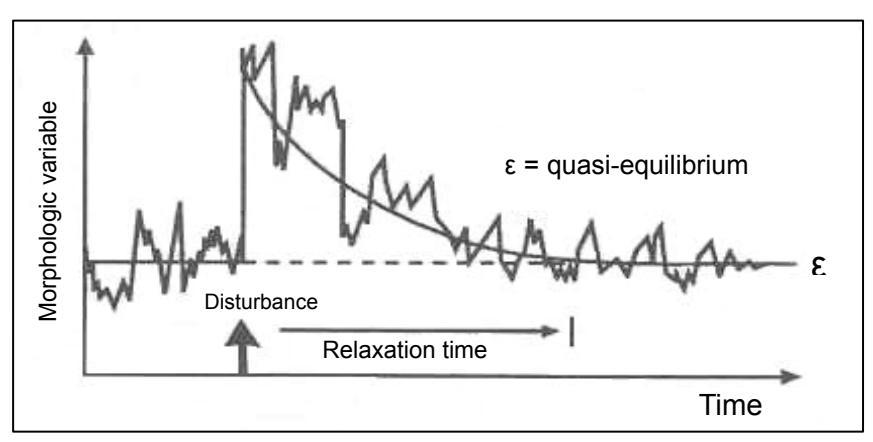
Figure 6: Magnitude of channel adjustments through time following a disturbance relative to an equilibrium condition.

15. Natural events (e.g., large floods) and human activities (e.g., channel straightening) can sometimes greatly alter the channel's configuration such that the river is temporarily removed from an equilibrium condition. Following the channel-altering disturbance, the river will undergo a series of adjustments that will bring the channel back into equilibrium (Petts 1994). The adjustments will initially be very rapid, but the magnitude and rate of change will decline through a relaxation period as the river once again approaches equilibrium (Figure 6). When a disturbance permanently alters watershed conditions, such as through urban development, the river will tend toward a new equilibrium condition with channel dimensions different from those associated with the earlier equilibrium state.

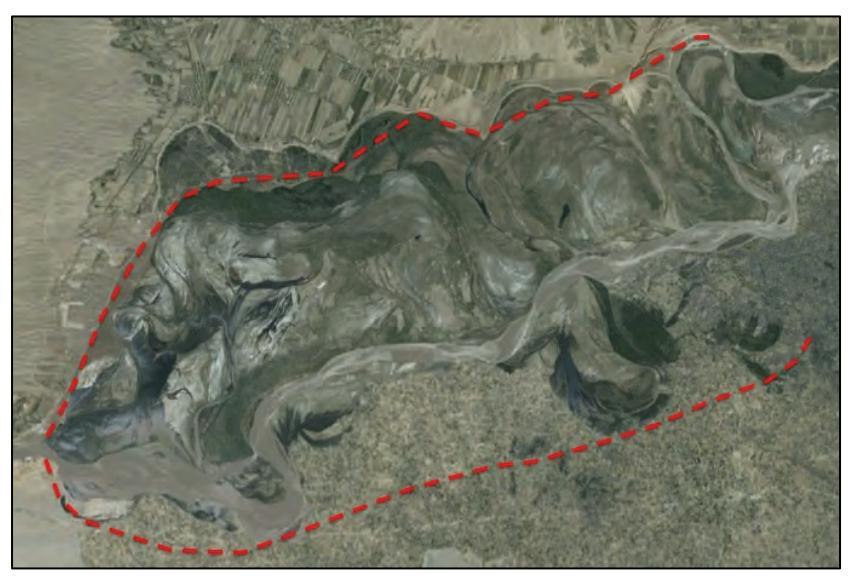
Figure 7: A wide meander corridor upstream of a narrow valley constriction at the lower end of the Kumsangir Fan. Note: Dashed lines demarcate outer limits of meander corridor. Source: Google Earth.

17. Meandering channels on the Pyanj River are restricted to the lower ends of the Hamadoni and Kumsangir fans where narrow valley constrictions lead to the development of wide meander corridors and high-amplitude meanders immediately upstream. Meander corridors tend to be much wider upstream of valley constrictions, because flood flows are unable to immediately transition from a wide floodplain to the narrow valley downstream. Consequently, floodwaters become impounded, flow is more easily deflected off of a straight course, and high-amplitude meanders are able to develop and grow at a rapid rate. The presence of oxbows in agricultural fields on the Kumsangir Fan highlights the potential for rapid meander growth to create severe erosion hazards along meandering channels (Figure 7).

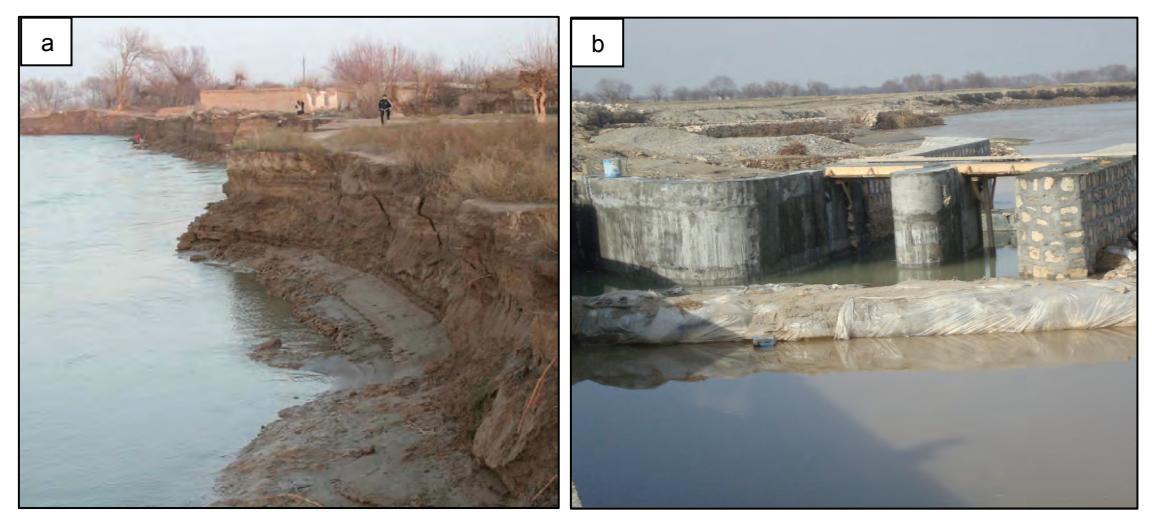
Figure 8: Bank erosion associated with meander growth. Source: Getinsa Ingenieria.

18. Although meandering channels are not prevalent on the Pyanj River, meandering is more common on the Kunduz and Vakhsh rivers—two large tributaries that join together with the Pyanj River to form the Amu Darya River. Bank erosion associated with meander growth on these rivers has caused considerable damage to homes on the Vakhsh River in Tajikistan (Figure 8a) and irrigation canal intakes on the Kunduz River in Afghanistan (Figure 8b).

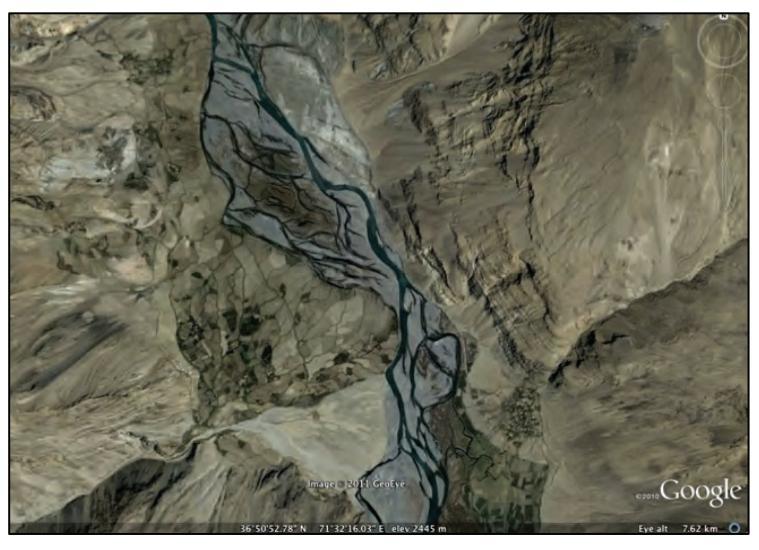
Figure 9: Braided channel in the Upper Basin of the Pyanj River. Source: Google Earth.

Braided channels 19. are characterized by multiple channel threads that split and rejoin or interconnect with other braided channels contained within a wider braid plain (Figure 9). Mid-channel bars, primarily composed of sand and gravel, separate the various channel threads. The braided pattern develops as flood flows loaded with sand and gravel begin to lose their sediment-carrying capacity at the waning stages of floods. As sediment is deposited in the channel, the flow is split around the emerging midchannel bars, resulting in a simple braided pattern. Generally, one braid path conveys a greater portion of the

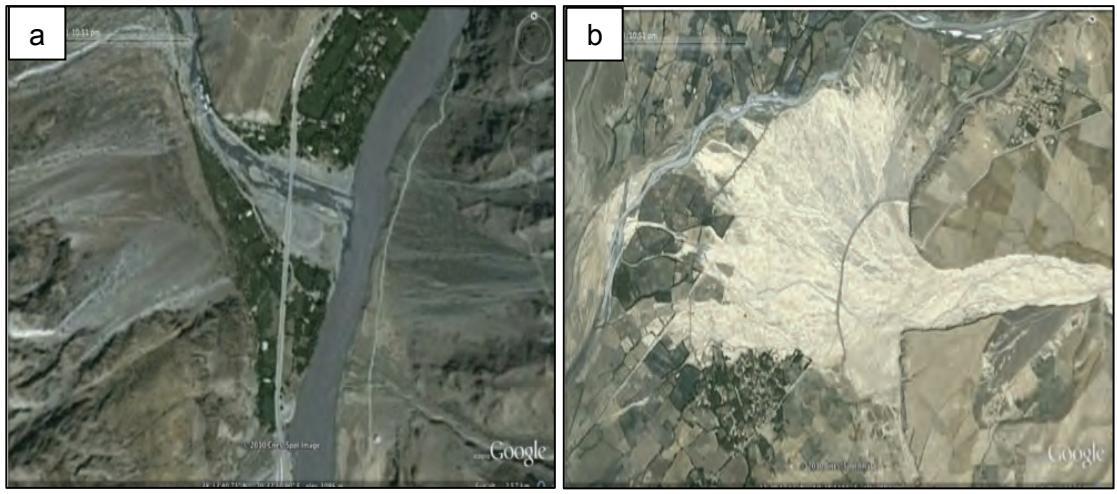
Figure 10: Alluvial fans can be inundated over (a) a small portion of the fan surface, or (b) the entire fan surface during a large flood. Source: Google Earth.

27. River channels flowing on an alluvial fan generally occupy only a portion of the fan surface at any given time (Figure 10a), with the periodic shifting of the active channel due to sediment infilling giving rise to the characteristic fan shape. In some instances, the entire fan surface can be active during larger floods, although flow is concentrated on a small portion of the fan surface during smaller discharges (Figure 10b). The channels crossing alluvial fan surfaces in dry climates are typically braided (Cazanacli et al. 2002), as in the Pyanj River Basin, but meandering channels may be present on alluvial fans in more humid regions (Stanistreet and McCarthy 1993). Alluvial fans are considered as a separate channel type herein, because of the unique process by which the channel shifts across the fan surface. Unlike braided channels on the valley bottoms, the position of the entire braid plain on an alluvial fan is subject to rapid shifting in a process known as channel avulsion (Field 2001).

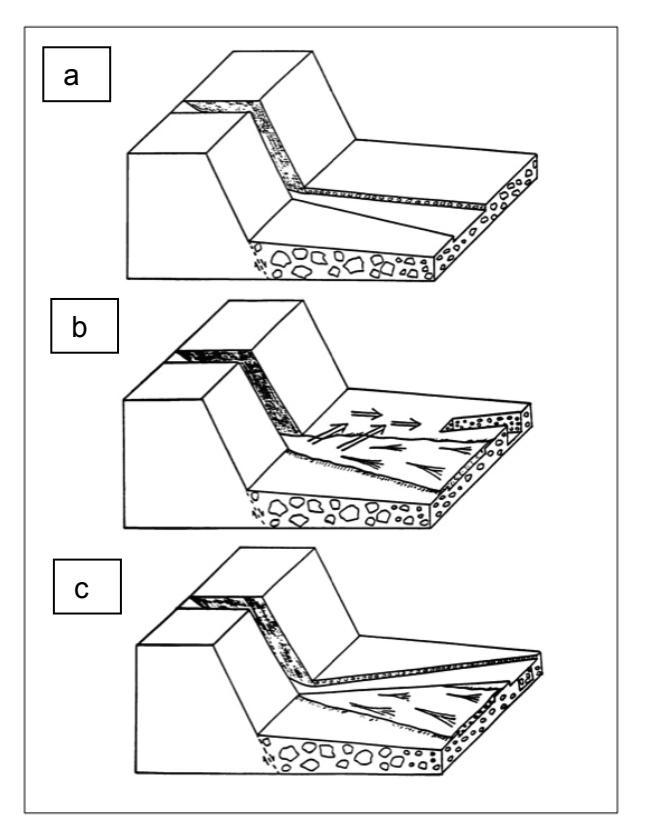
Figure 11: Schematic diagram of a channel avulsion on an alluvial fan. Source: Getinsa Ingenieria.

28. An avulsion on an alluvial fan begins as sediment builds up over time in the active channel due to a loss in the river's capacity to transport material across the expanding fan surface (Figure 11a). The resulting channel infilling leads to a decrease in channel depth and an increase in the amount of overbank flow escaping onto the fan surface. While this overbank flow initially spreads out across a wide area, it eventually begins to reconcentrate in natural (or man-made) depressions on the fan surface (Field 2001). Since the overbank flow is relatively free of sediment, the reconcentrated sediment-free flow can be erosive and the initially small depression in which the flow is concentrated begins to widen, deepen, and advance headward toward the source of the overbank flow-the active channel that is filling in with sediment (Figure 11b). Eventually, the growing channel erodes back to the active channel and, since the bed level of the newly formed channel is generally lower than the actively infilling channel, the majority of the flow will preferentially shift to the position of the new channel, completing the avulsion process (Figure 11c).

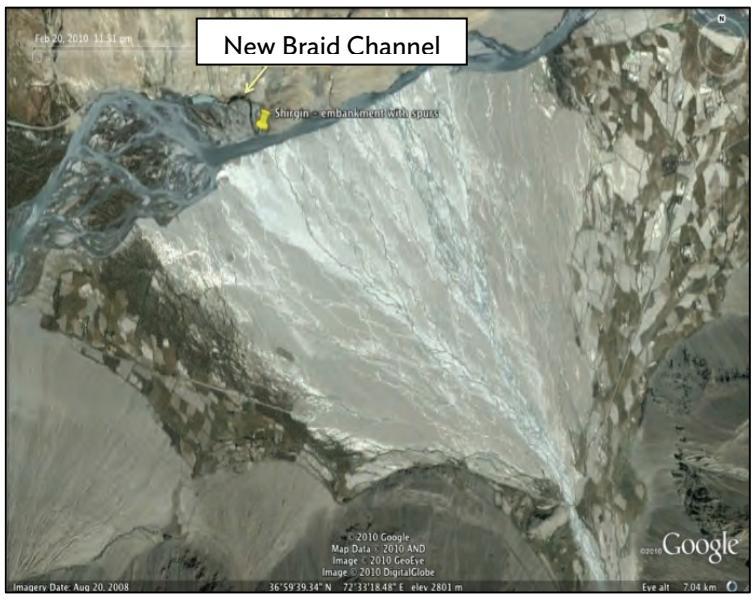
Figure 13: Large alluvial fans in the Upper Basin growing into the Pyanj River's path at the bottom of the valley. Source: Google Earth.

33. More than 200 alluvial fans, many of them with some human settlement, are found along the flanks of the Pyanj River in the Upper Basin. Most of the settlement is situated on active alluvial fan surfaces, as evidenced by the poorly developed soils and the potential for rapid sediment delivery from the tectonically active, landslide-prone mountains to infill the shallow channels during a single flood. The stark contrast between the steep mountains and flat valley bottom means the fans have not yet reached an equilibrium state when fanhead trenches are most likely to form. Consequently, the settings of nearly all of the settlements on the Upper Basin fans must be considered hazardous, even in areas that have been free of flooding for decades. In addition to the direct threats to human developments on the alluvial fans themselves, the largest alluvial fans in the Upper Basin strongly alter the morphology of the Pyanj River by growing into the river's path along the valley bottom (Figure 13). Bank erosion caused by this forced migration of the Pyanj River threatens agricultural fields, roads, and some settlements along the narrow floodplains across from and adjacent to these large fans.

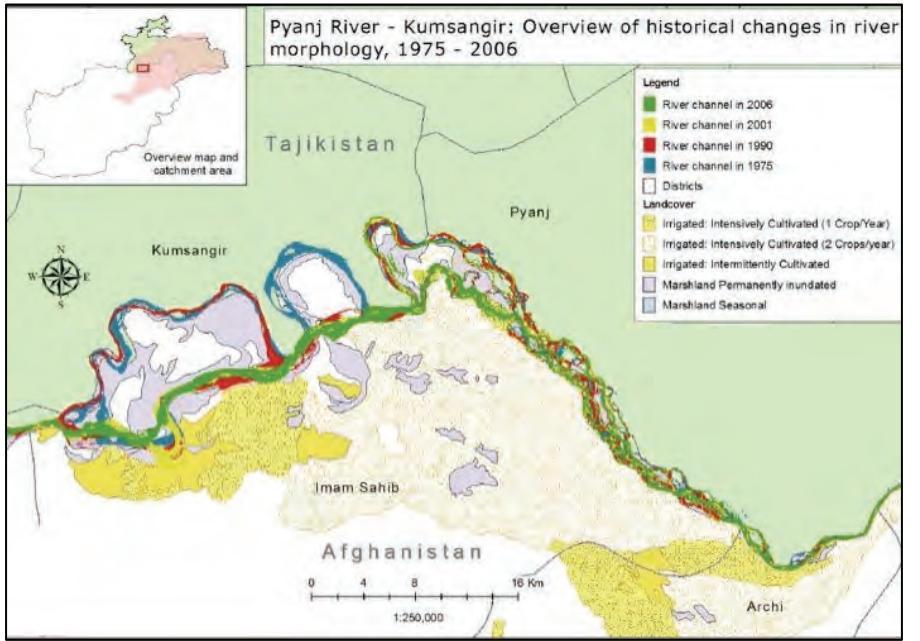
The mapping of the historical changes in river morphology is based on land cover classification of multispectral and multitemporal satellite imagery for 1975, 1990, 2001, and 2006.

Figure 14: The position of active channels on the Kumsangir Fan between 1975 and 2006. Source: Global Land Cover Facility.

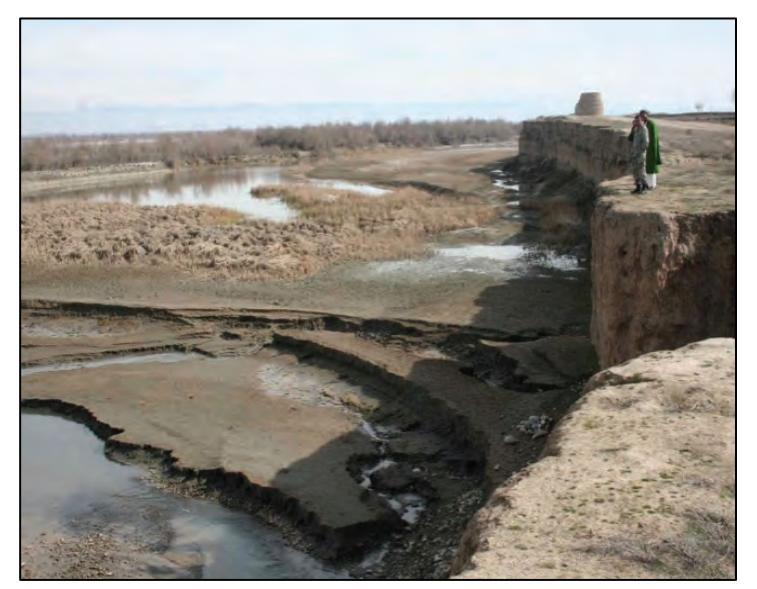
Figure 15: A fanhead trench on the upper Kumsangir Fan has left the adjacent surface several meters above the valley bottom in places. Source: Getinsa Ingenieria.

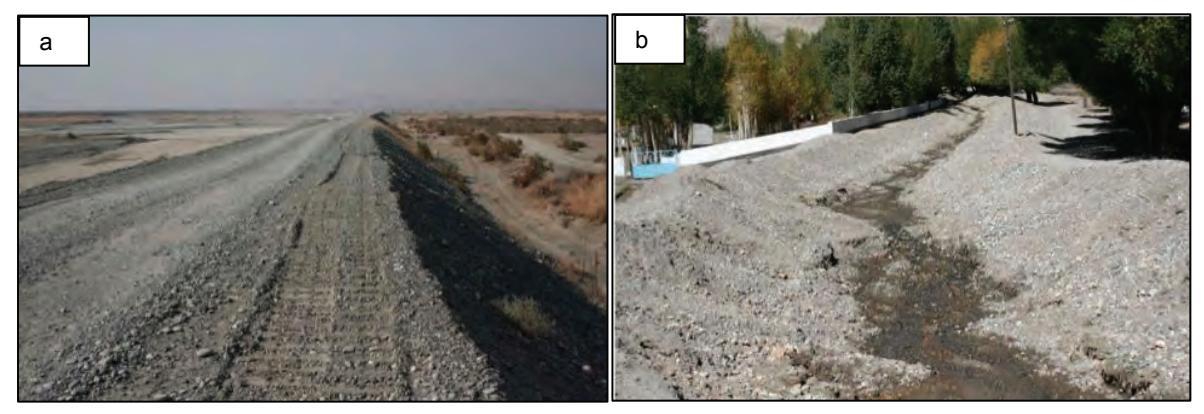
Figure 16: Embankments in the Pyanj River Basin found on (a) the mainstream, and (b) alluvial fans at the terminus of smaller tributaries. Source: Getinsa Ingenieria.

40. Embankments (also known as levees, dikes, bunds, or berms) are linear ridges of earthen material typically constructed with local riverbed and floodplain sediments. The purpose of embankments is to prevent flow from accessing side channels or spilling out onto the adjacent flood-prone surface (be it a floodplain or alluvial fan), thus protecting vast areas of arable and developable land. In mountainous countries, such as Tajikistan, there is a great deal of pressure to settle and farm in flood-prone areas, so embankments are often used as a flood control technique. Embankments in the Pyanj River Basin are found on the river's mainstream (Figure 16a) and on alluvial fans at the terminus of smaller tributaries (Figure 16b). The longest and largest embankment is on the Hamadoni Fan. This embankment, first built during Soviet times in the 1930s, blocks access to nearly half of the fan area (including two former channels) and allowed the development of an extensive irrigation system and associated villages on the northern half of the fan (Figure 17). The river has been restricted to the unprotected areas to the south for more than 70 years with no major avulsion of the channel persisting north of the embankment since its construction.

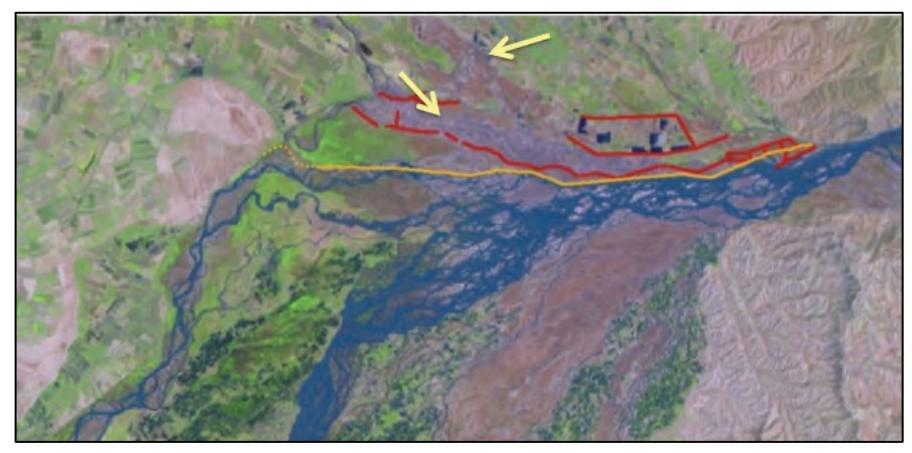
Figure 17: Satellite imagery of the Hamadoni Fan showing location of two overflow channels (arrows).

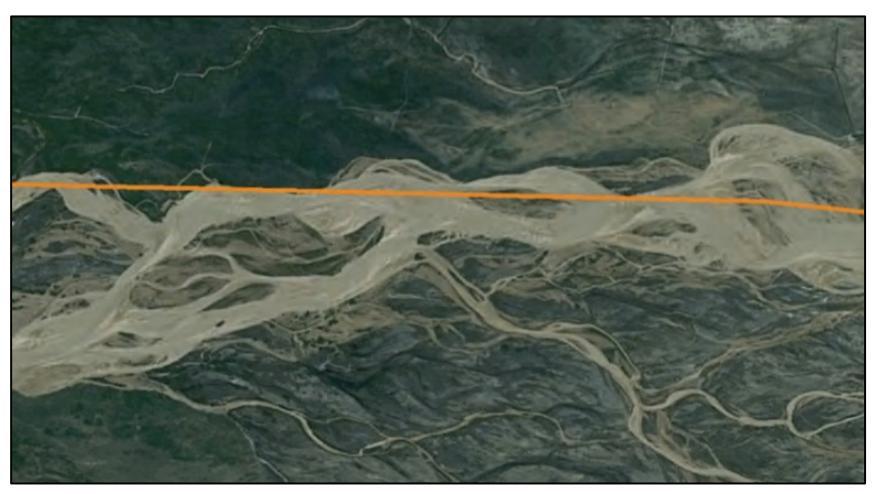
Figure 18: The embankment on the Hamadoni Fan, as shown by the global positioning system track (hard line), was built into an active channel and has cut off several meanders. Source: Google Earth.

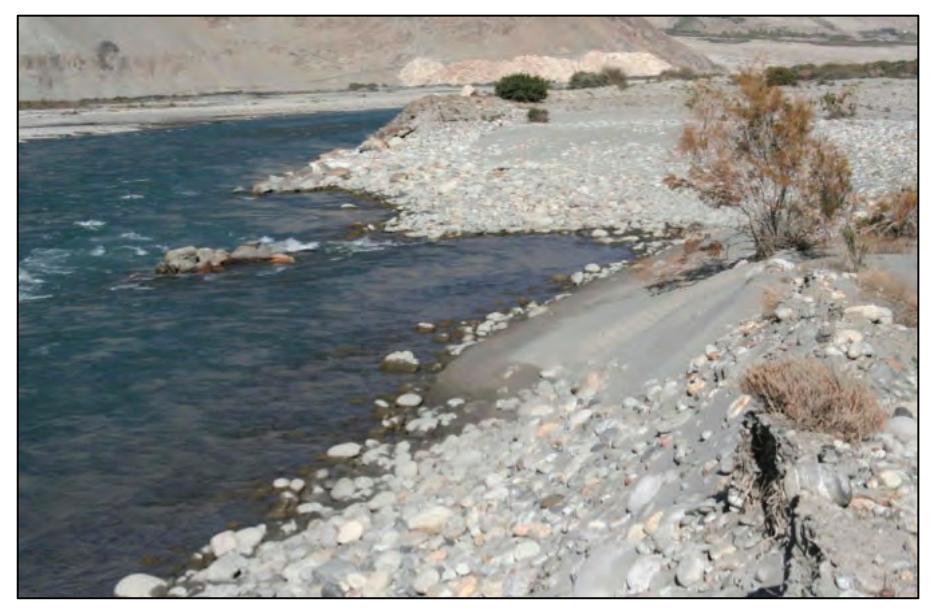
Figure 19: Breach in an embankment in the Pyanj River Upper Basin. Source: Getinsa Ingenieria.

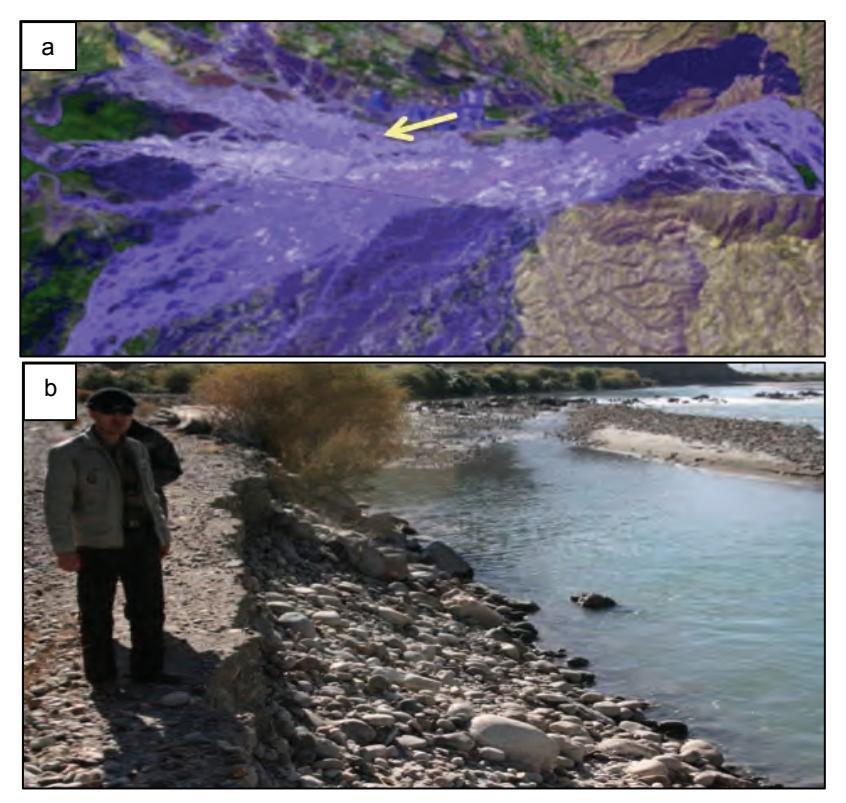
Figure 20: Potential modes of embankment collapse: (a) seepage and piping as on the Hamadoni Fan during the 2010 flood (arrow shows seepage flow in old channel north of embankment), and (b) scour and undermining as in the Pyanj River Upper Basin. Note: Overtopping is not illustrated. Sources: (a) Google Earth; (b) Getinsa Ingenieria.

allowing flows to more readily pass under or through the flood control structure. The problem is particularly acute in lower-gradient areas where prolonged high flows lead to saturation and weakening of the embankment materials. However, seepage or piping can also occur in highergradient settings, such as the Pyanj River (Figure 20a). By confining flows, embankments increase flow velocities in the channel itself, which in turn enhances scour, undermining, and potentially embankment collapse (Piégay et al. 2006). Embankment undermining is a problem in the Pyanj River Basin and elsewhere in Asia (Figure 20b).

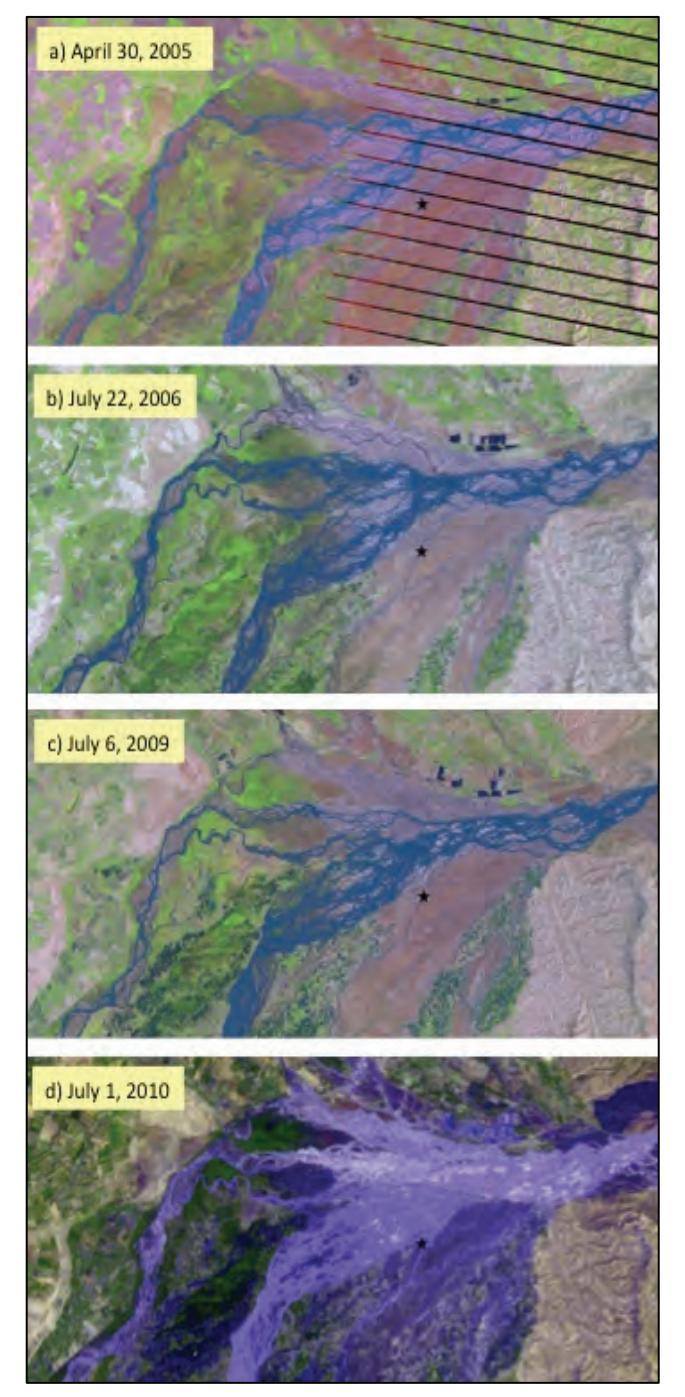
Figure 21: Satellite images of the Hamadoni Fan through time, showing recession of the southern bank of the central channel caused by embankment reconstruction: (a) 30 April 2005, (b) 22 July 2006, (c) 6 July 2009, and (d) 1 July 2010.

Embankments can also impact adjacent 43. areas that remain unprotected by flood control structures. Evidence for such interactions is present on the Hamadoni Fan. Embankment reconstruction along the northern channel caused significant morphological impacts on the adjacent central channel, because long, temporary spurs were built during construction to divert flows away from the northern channel. In direct response to these actions, the southern bank of the central channel receded almost 1,000 meters during 2006-2010, corresponding with the time of embankment reconstruction (Figure 21). The continuing channel adjustments resulting from the embankment reconstruction on the northern channel are also responsible for eroding croplands (Figure 22a) and undermining bridge abutments on the central channel (Figure 22b). In contrast, the large 2005 flood, which breached the embankment and reactivated old channels north of the embankment, caused no significant damage along the central channel despite the record discharge. Therefore, the dramatic changes since that time must be related to reconstruction of the embankment and concentration of flow into the central channel.

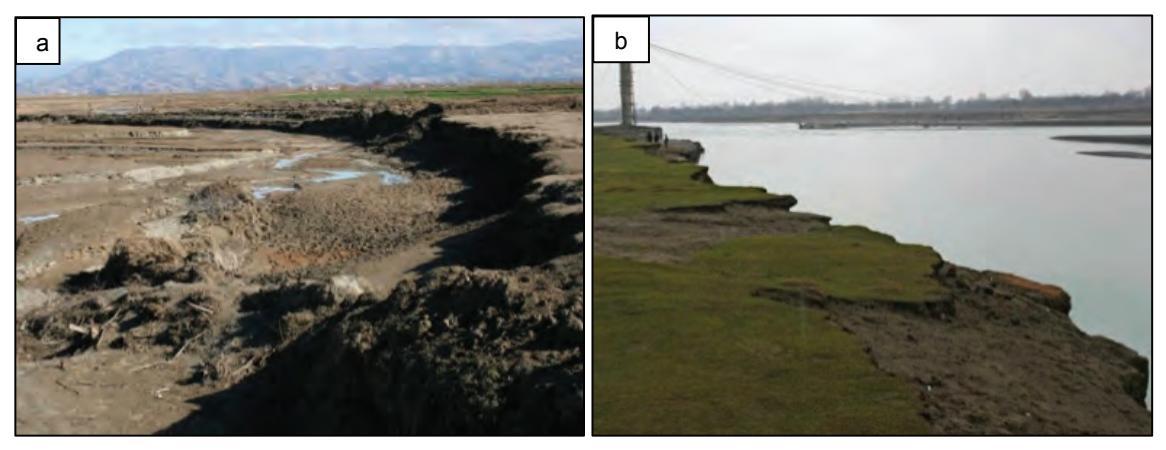
Figure 22: Effects of embankments on adjacent areas include bank erosion that threatens (a) croplands, and (b) other investments such as bridges. Source: Getinsa Ingenieria.

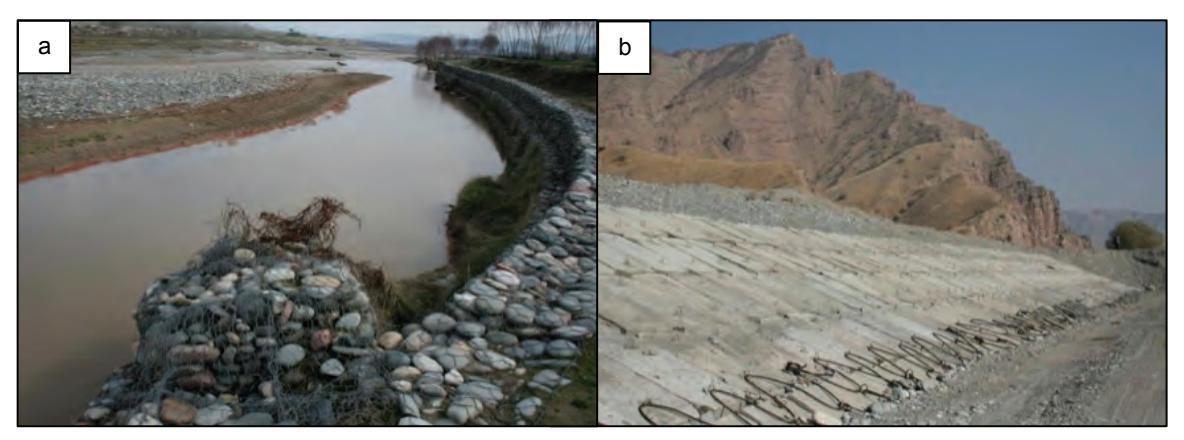
Figure 23: Armoring of (a) river banks with gabion baskets, and (b) embankments with concrete blocks, in the Pyanj River Basin. Note: Large boulders are used for armoring elsewhere in the Pyanj River Basin.

45. Bank armoring involves the lining of a riverbank with hard materials that will resist the forces of erosion acting on the bank (Figure 23a). Concrete blocks, large boulders, or gabion baskets are the materials most frequently used to arrest bank erosion and protect agricultural fields and human infrastructure. Armoring is also commonly used on embankments to prevent the scouring and undermining that lead to structure collapse (Figure 23b). Bank hardening causes increased local scour that can sometimes "attract" the river to the protected area by scouring a deeper channel to which the main flow path migrates (Mosselman 2006). Four reasons have been identified for deeper scour along armored banks: (i) loss of sediment supply from the once-eroding bank; (ii) channel narrowing and concentration of flow as a point bar on the opposite bank grows toward the armored bank; (iii) local scour effects caused by flow deflection into the channel bed; and (iv) bend deformation, leading to greater energy expenditure due to local prevention of channel migration (Mosselman 2006). As a result of these factors, the greatest scour along the river can occur in the least desirable location—along the

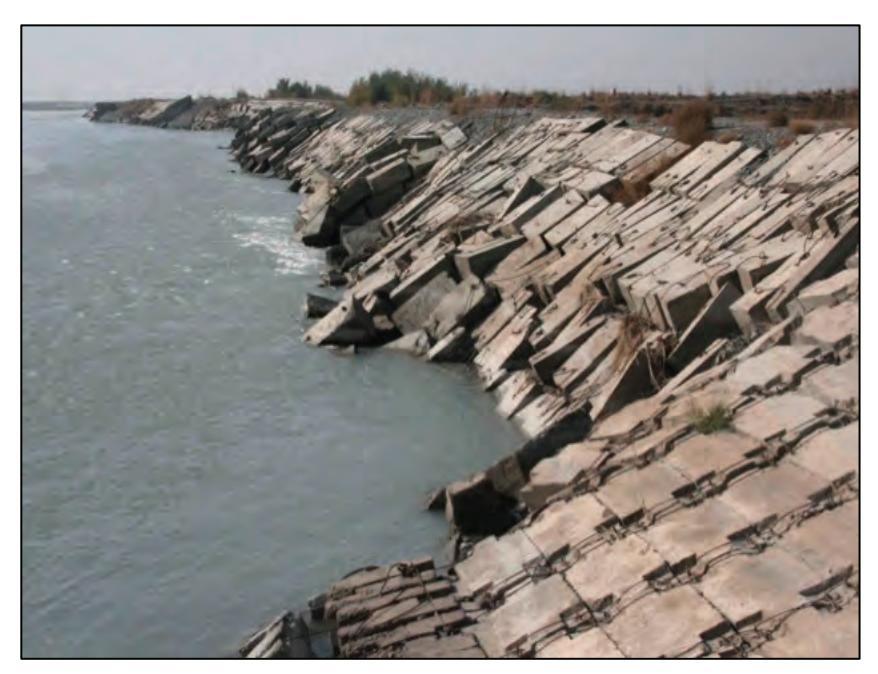
Figure 24: Undermining of concrete blocks armoring the embankment on the Hamadoni Fan has caused their collapse into a scour hole. Source: Getinsa Ingenieria.

protected bank or embankment. The undermining of armored embankments is common in the Pyanj River Basin, as elsewhere in Asia, and has been identified as one of the primary mechanisms for the failure of bank-armoring efforts (Fischenich 2003) (Figures 20b and 24). Launching aprons can increase the depth of scour protection where it is not feasible to excavate to an adequate depth to provide the necessary scour protection (Maynord and White 1995, 47).

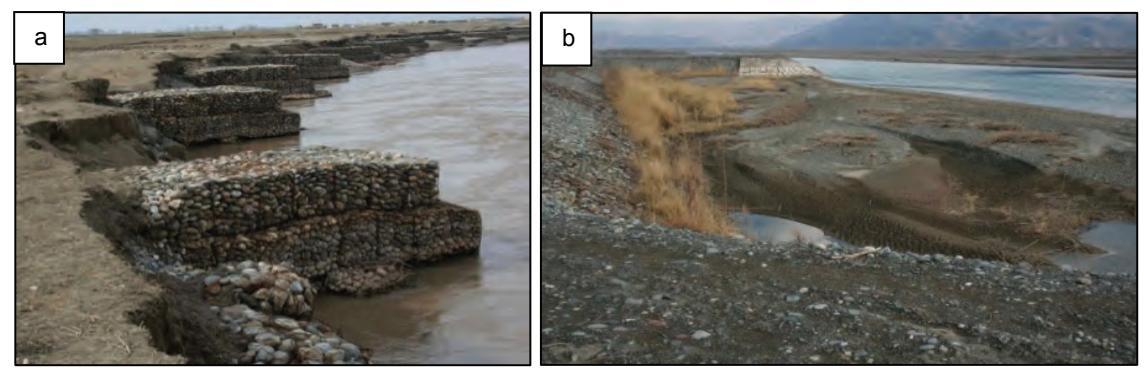
Figure 25: Flow deflection spurs in the Pyanj River Basin are built using (a) gabion baskets in Afghanistan, and (b) concrete blocks in Tajikistan. In some cases, as in (b), the concrete blocks armor the tips of spurs built primarily with earthen materials. Source: Getinsa Ingenieria.

48. Flow deflection spurs in the Pyanj River Basin are generally narrow linear structures extending from the bank out into the river channel, and composed of gabion baskets and concrete blocks. By redirecting flow away from the bank, a series of multiple spurs can be used to protect an eroding bank (Figure 25a), and can also be incorporated into embankments to prevent scour and undermining of those structures (Figure 25b). If working properly, spurs reduce the velocity of flow near the bank and facilitate sediment deposition between the spurs. Scour at the tips of the spurs helps to shift the thalweg (line following the lowest part of a valley) away from the bank and out to the ends of the spurs. In some cases, as in Figure 25b, concrete blocks armor the tips of spurs, which are built primarily with earthen materials.

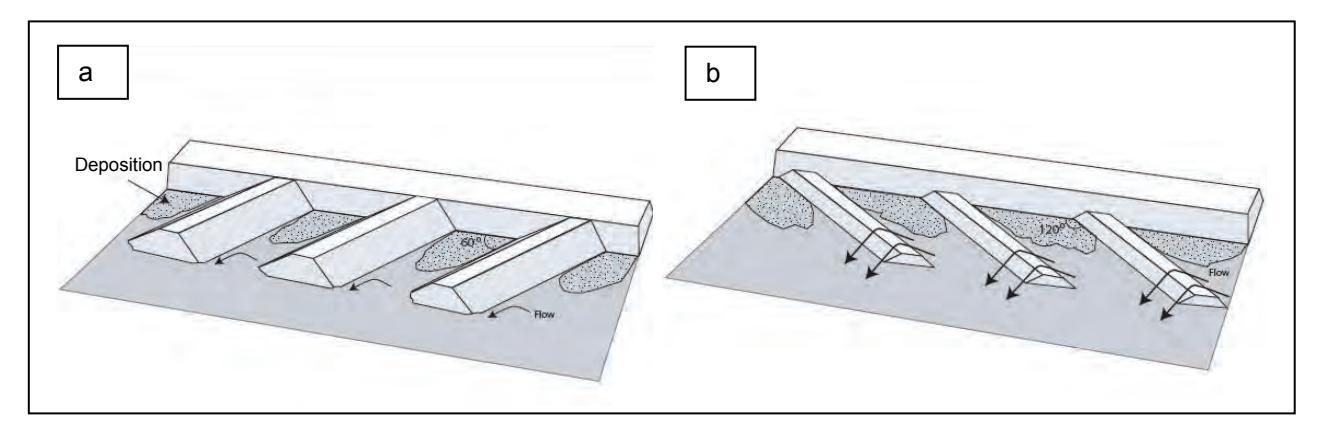
Figure 26: Spurs can be oriented (a) downstream as attracting spurs, or (b) upstream as repelling spurs. Source: Getinsa Ingenieria.

49. Other names used for flow-deflection spurs include groins, vanes, deflectors, and bendway weirs. The terms are essentially interchangeable, but, beyond terminology, the critical factors when designing spurs are their orientation, height, and spacing (as spurs are rarely used in isolation). Attracting spurs are angled downstream and must be constructed to a sufficient height to capture (or attract) all flows within the channel, including flood flows, and push water away from the bank (Figure 26a), while repelling spurs are built much lower and angled upstream in order to turn (or repel) water away from the bank (Figure 26b). Floods that overtop repelling spurs flow off the structure perpendicular to its orientation. In the Pyanj River Basin, the spurs have almost exclusively been angled downstream and are intended to function as attracting spurs.

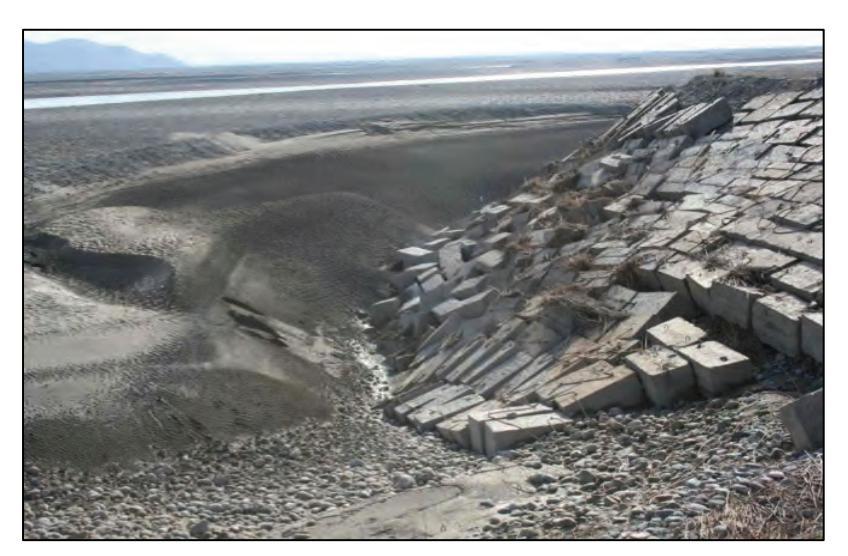
Figure 27: Scour and undermining on a spur on the Hamadoni Fan embankment has caused collapse of concrete armoring blocks. Source: Getinsa Ingenieria.

armored surfaces. Scour occurs both on the upstream ends of attracting spurs, where flow is partially directed downward into the channel bed, and at the tips of the spurs where the deflected flow is concentrated. Often, after high flows recede, a continuous scour hole is seen that extends from the upstream face of the spur and wraps around its tip. Spurs should not extend across more than onethird of the channel's low-flow wetted width in order to reduce flow concentration, limit scour at the spur tips, and avoid deflecting flow into the opposite bank.

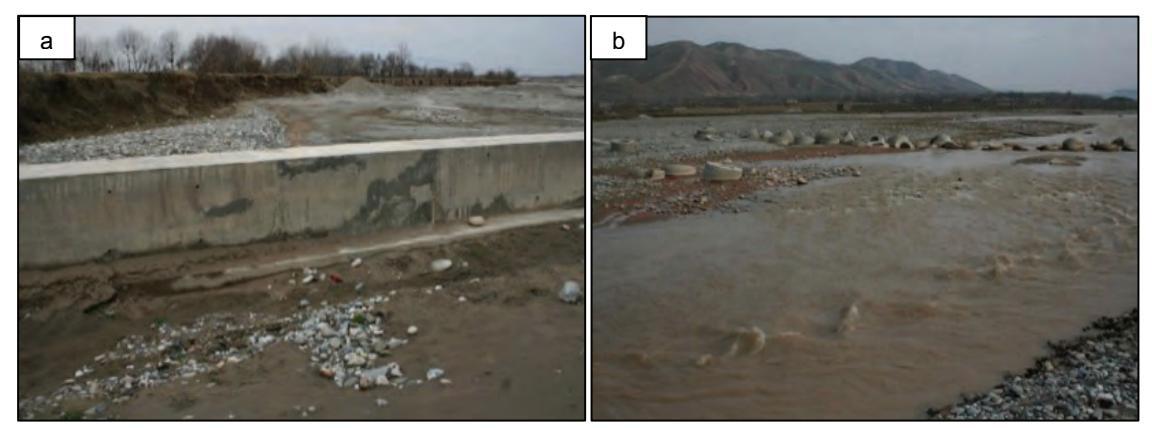
Figure 28: Spurs angled downstream that are too low can aggravate bank erosion when overtopped whether they (a) were originally constructed too low, or (b) become lower due to settling.

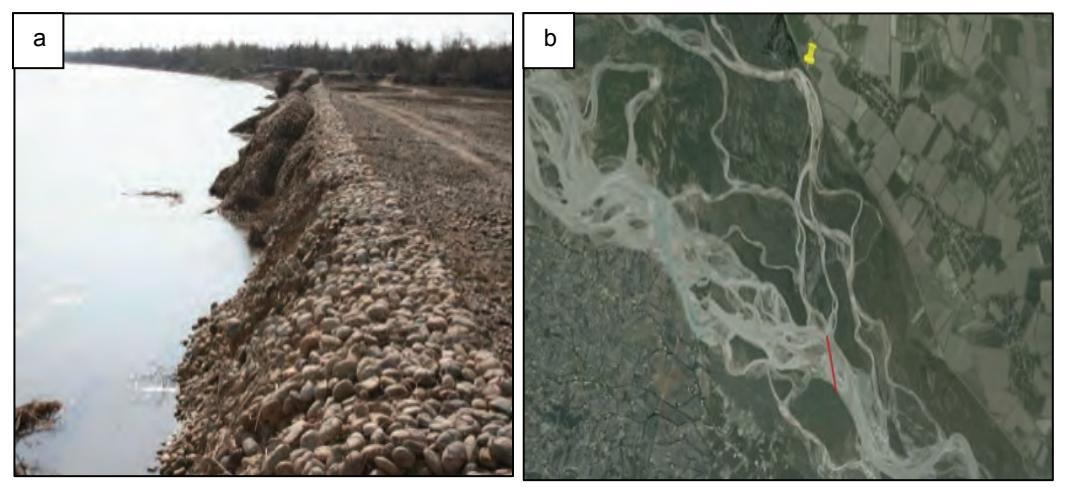
Figure 29: Walls (a) built across the upstream end of braid channels prevent erosive flows from entering the channel (note the collapse of the gabion wall), but (b) can transfer flow to other channels where bank erosion accelerates.

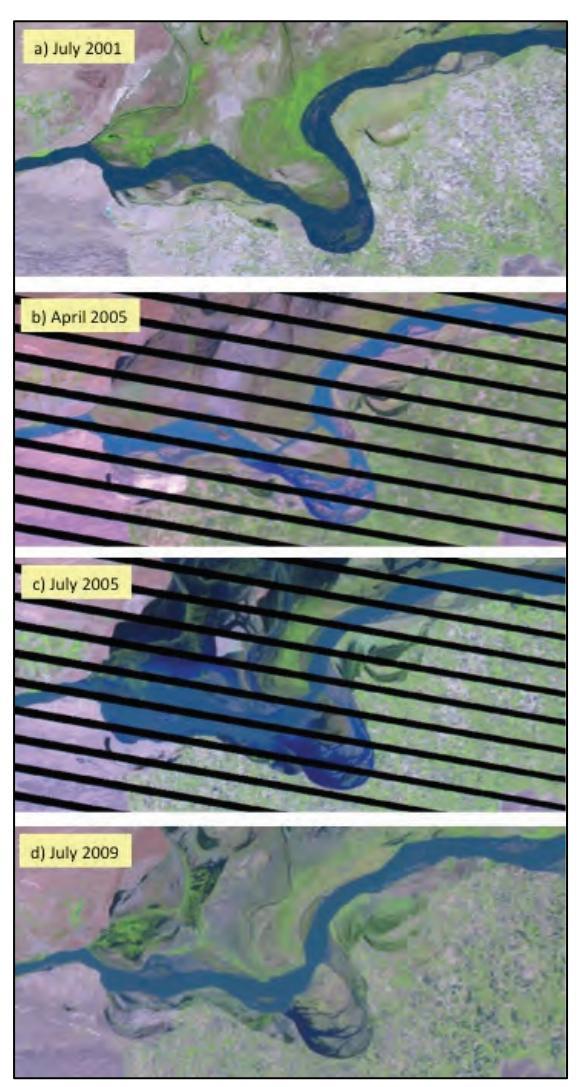
Figure 30: Erosion on the outside bend of a meander on the lower Kumsangir Fan was halted after a trench was cut across the inside bend of a meander to straighten the channel. Source: Getinsa Ingenieria.

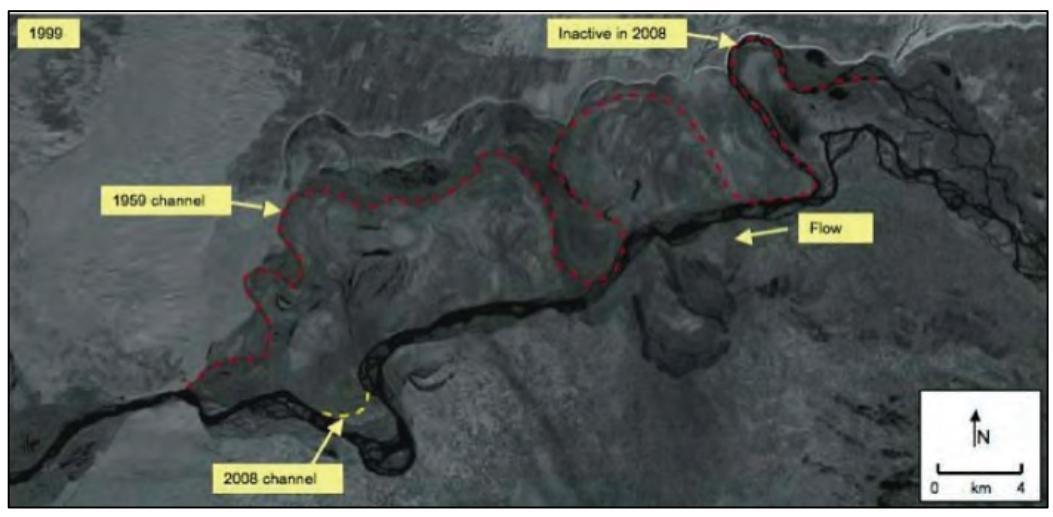
Figure 31: The Pyanj River on the lower Kumsangir Fan straightened over time by cutting off individual meanders. Source: Google Earth.

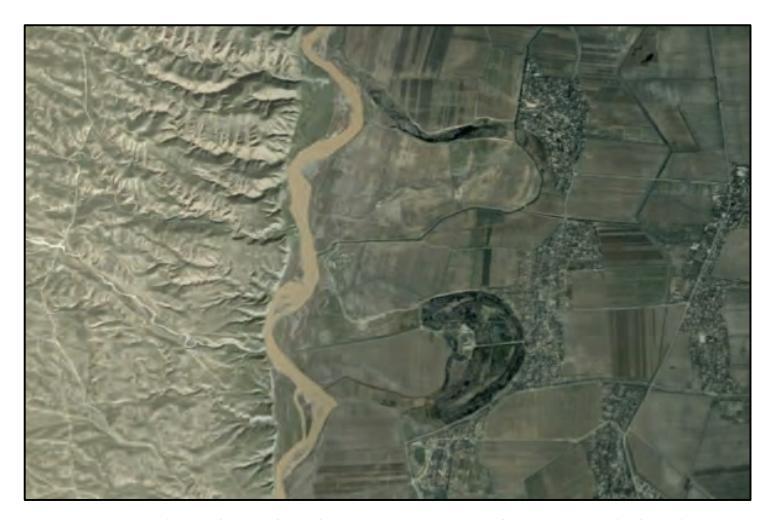
Figure 32: Abandoned oxbows are an indication of the former meander corridor on the Kizilsu River before straightening. Note: New meanders reforming along straightened channel are of much lower amplitude. Source: Google Earth.

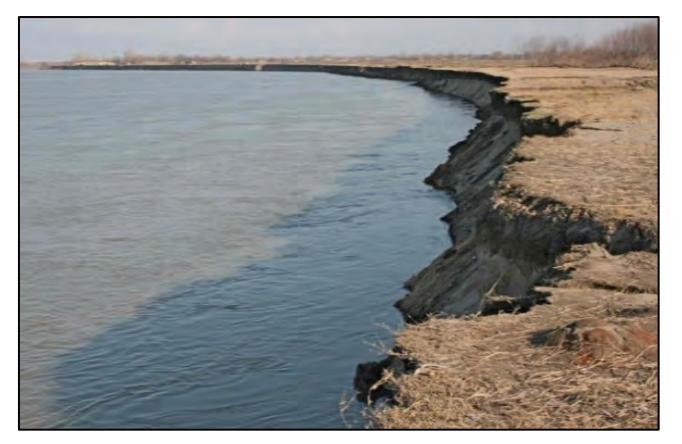
Figure 33: Severe bank erosion at Qadam Jai, Afghanistan. Source: Getinsa Ingenieria.

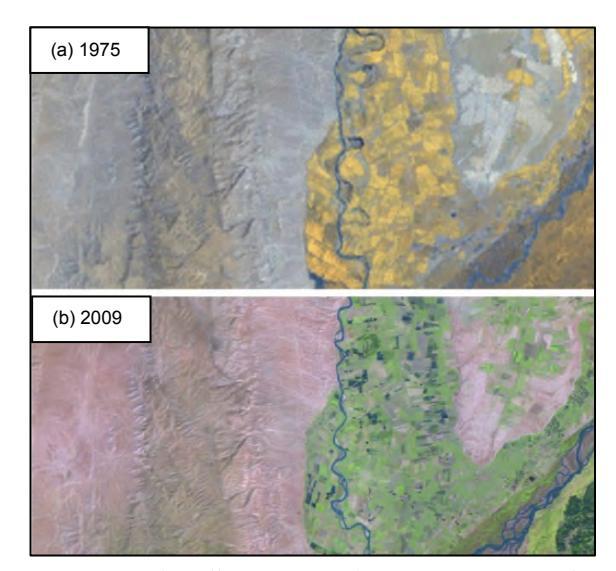
Figure 34: Satellite images from (a) 1975, and (b) 2009 showing the reformation of meanders along straightened reaches of the Kizilsu River. Source: Getinsa Ingenieria.
