# PYANJ RIVER MORPHOLOGY AND FLOOD PROTECTION

July 2014

## ADB CENTRAL AND WEST ASIA WORKING PAPER SERIES

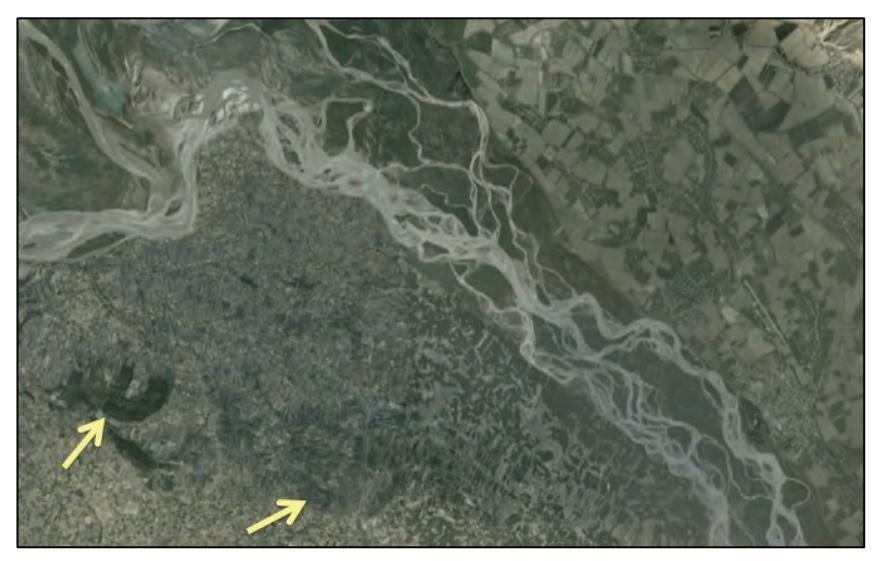
Figure 36: Vestiges of old meanders (arrows) amid agricultural fields and villages indicate this low area protected by poorly constructed earthen embankments was recently part of the active river channel on the Kumsangir Fan. Source: Google Earth.

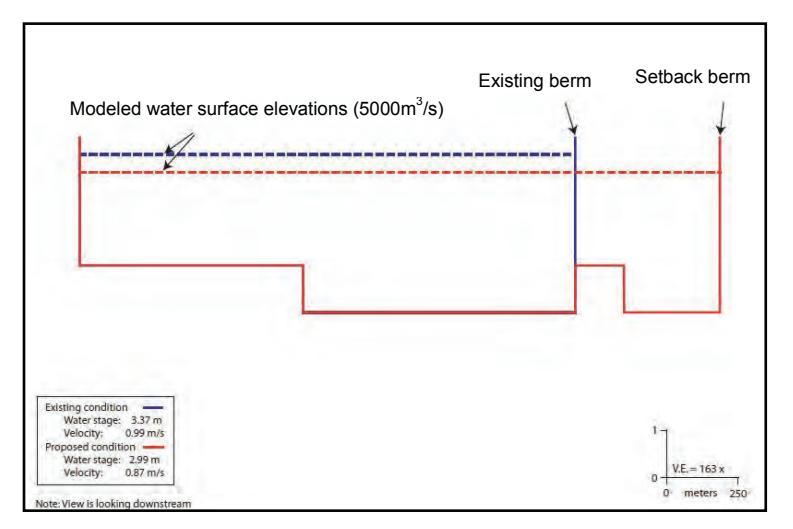
Figure 37: Simplified cross section of the Hamadoni Fan used in HEC-RAS hydraulic model to compare river stage for a 5,000 cubic meters per second flood contained by the existing embankment and setback embankment. Source: Getinsa Ingenieria.

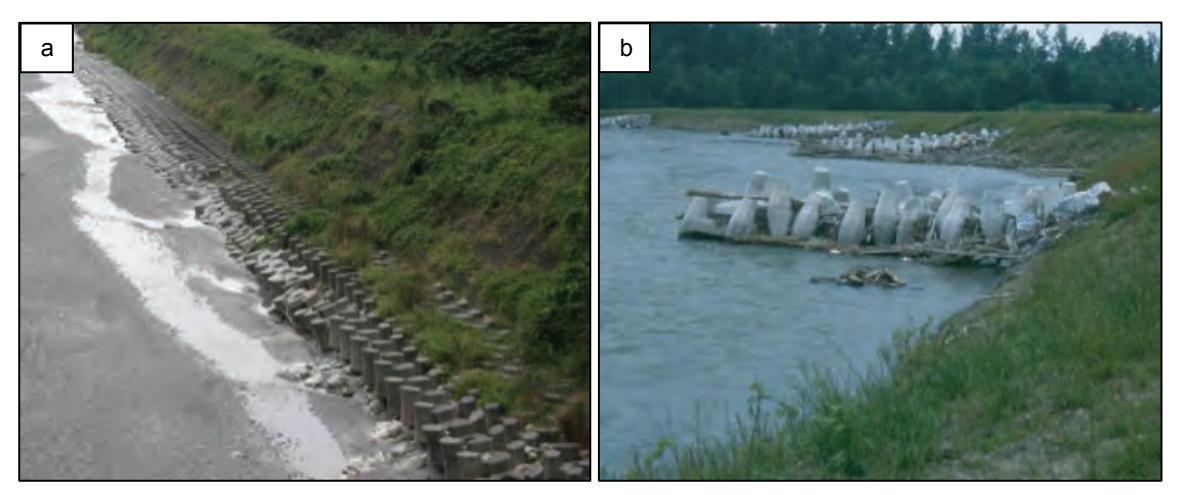
Figure 38: Dolos blocks of different shapes as (a) bank armoring (Taipei, China), and (b) repelling spurs (Washington State, United States) in riverine environments. Source: Getinsa Ingenieria.

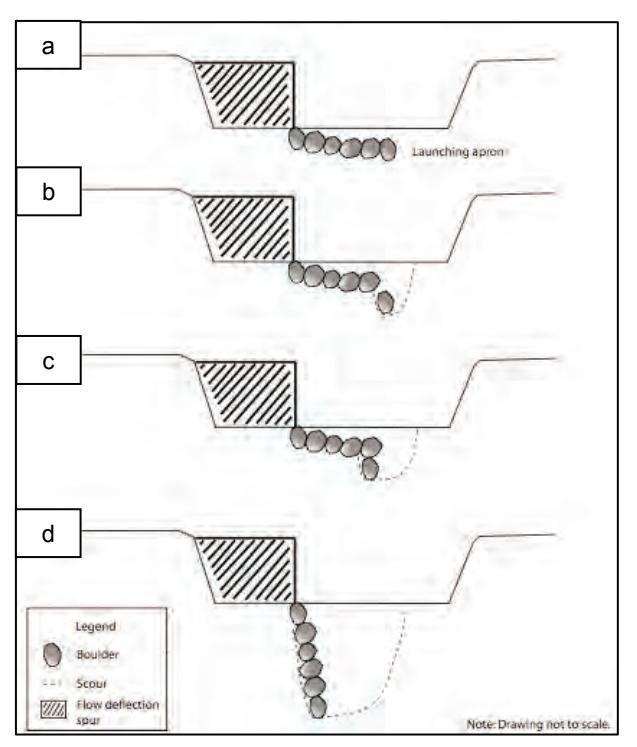
Figure 39: Launching aprons extend out from a structure at a low angle (a) with boulders or concrete blocks falling into the growing scour pit as the launching apron is undermined (b-d). Note: Actual launching aprons would not extend as far across channel as shown in this schematic diagram.

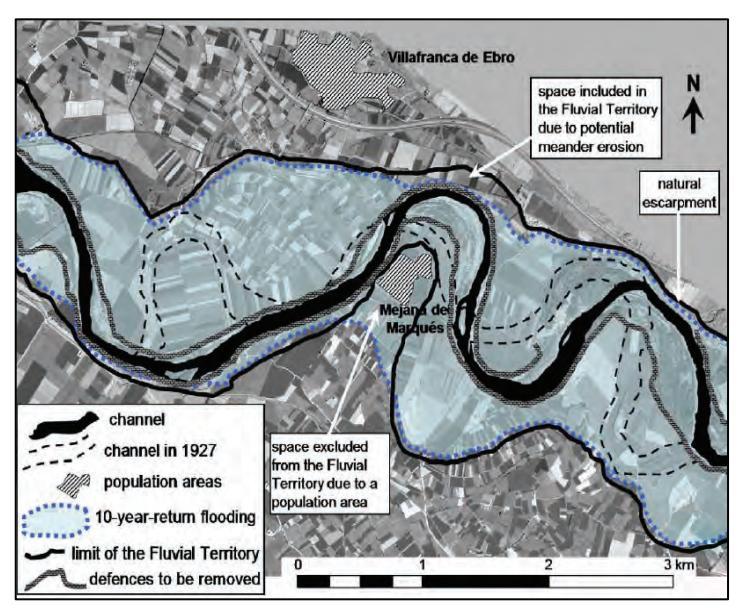
Figure 40: Fluvial territory, or attenuation zone, delimitation in a reach of the middle Ebro River, Spain. Source: Ollero, A. 2010. Channel changes and floodplain management in the meandering middle Ebro River, Spain. Geomorphology. 117. pp. 247–260.
