# **HERITAGE ARCHITECTURE OF BATANES ISLANDS IN THE PHILIPPINES: A SURVEY OF DIFFERENT HOUSE TYPES AND THEIR EVOLUTION**

By: Archt. Jose F. Ignacio, UAP  
College of Architecture University of the Philippines

REPORT

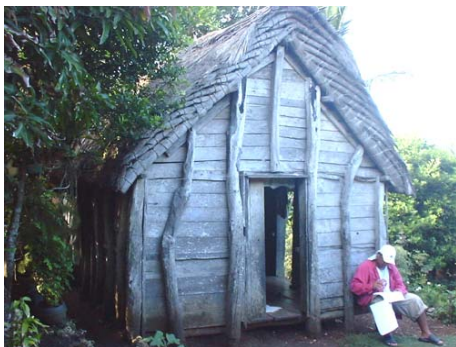
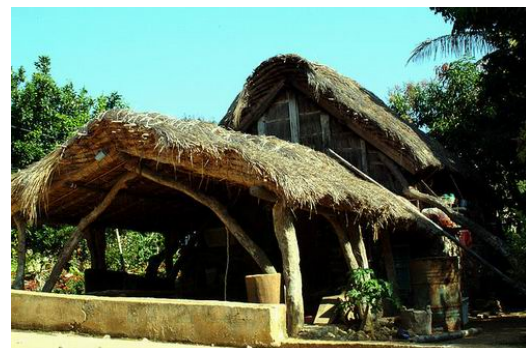
Fig. 4 & 5, WT (Wood-and-Thatch) Houses

- *WT* (wood-and-thatch) - These structures use thatch, wood planks, wood studs, reeds, or a combination of these. They are usually smaller and built with less height compared to those made of stone walls. These are limited to single story structures. Most *WT* structures are used as storage or kitchen areas. In addition, along coastline villages, the *WT* structures may serve as temporary dwellings during harvest season for fishing and other agricultural activities.

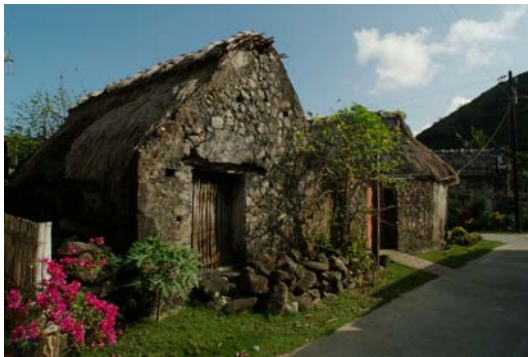
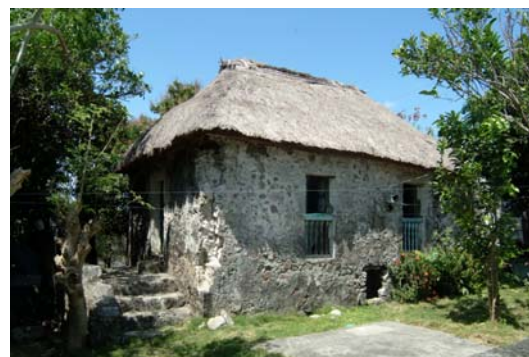
Fig. 6 & 7, *LSWT* (Lime-Stone-Wood-and-Thatch) Houses

- *LSWT* (lime-stone-wood-and-thatch) – These structures use stones of varying sizes from gravel to boulders. Different stones are used including volcanic, basalt, metamorphic, and the like. Coral stones are also commonly used particularly in areas close to the sea. Stones are piled and bound together by applying lime mortar, forming a strong, interlocking edifice. The building system allows for a larger floor area and a two-storey frame. During the rainy season, the lower level is usually used as storage for food and as shelter for animals. During summer, it is used for storage of agricultural products such as yam, sweet potato, wood and charcoal while the upper level is used as the main living quarters. A wood floor separates the two levels.

The *LSWT* structures are commonly used as the main house and the *WT* types as the kitchen or the storage and on certain occasions as temporary dwelling during harvest season.

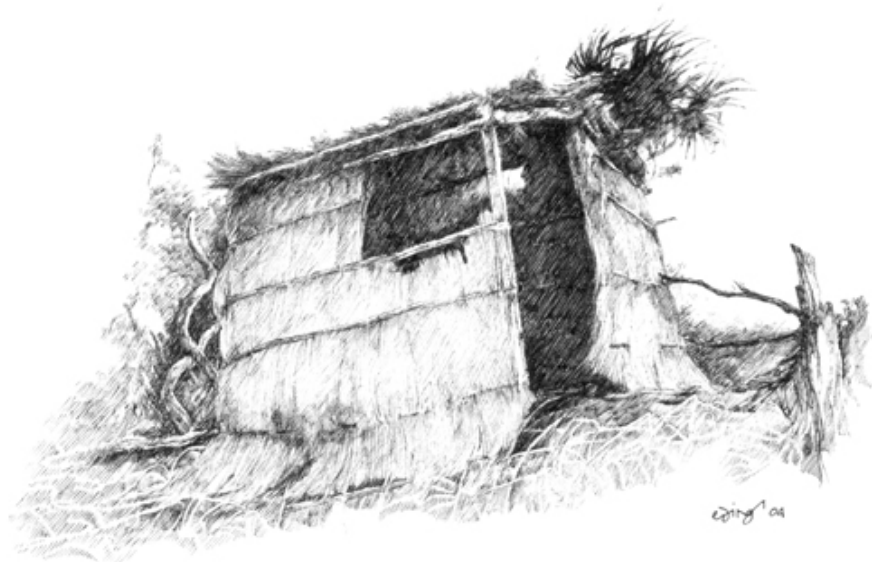
**Illus. 1. The “*Lagatiti*” Shelter**

This is a makeshift type of shelter resembling an ethnic lean-to. It is commonly used as a temporary shed in farmlands. It is a small structure just over 4 square meters in floor area. It has a two-slope roof with one slope long enough to touch the ground and the other being a lot shorter almost resembling a roof eave. (Illus. 5)

The roof is made of thatch or any type of broad grass leaves. Reeds or long branches placed above and below keeping the thatch in place. Tree trunks are driven into the ground to serve as posts to support the roof assembly. The perimeter posts are just about one and a half meters high. This creates a very low ceiling that forces a person to be constantly seated or squatted while inside. It has thatch walls on three sides with the sloping roof functioning as the wall for the remaining side. This reduces the space even further because of the tapering height of the roof-wall.

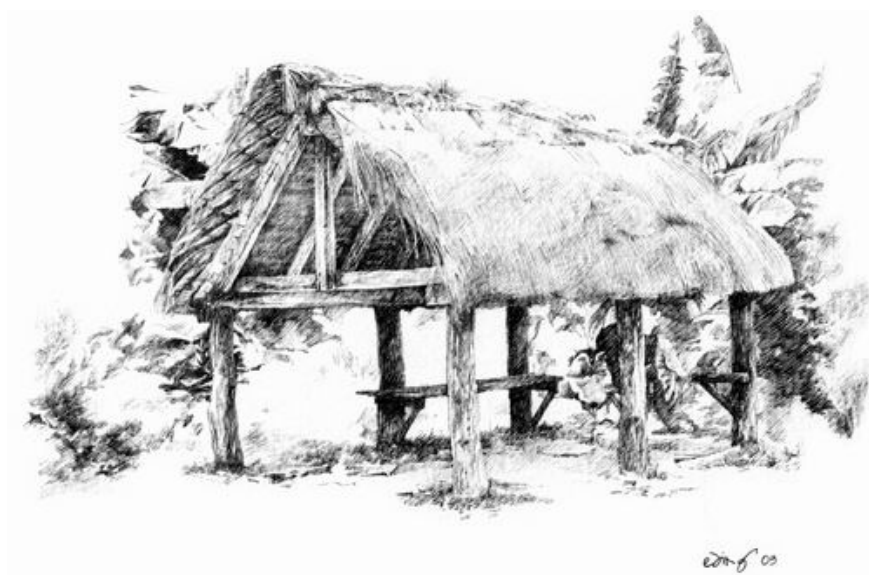
**Illus. 2. The “*Rahaung*” Shelter**

It may have no walls, although in a variation of this house type, the front and rear areas of the A-frame sometimes have wall-like barriers made of thatch. These barriers cover only the area from the level of the eaves to the top of the triangular frame, sort of elevated walls. They provide shelter from rain and sun, which would otherwise penetrate if these areas were left bare.

Low, narrow wooden platforms are built alongside the posts to serve as worktops, storage, or benches. This house type is used as a multi-purpose shelter to house boats or as a shed for various work activities.

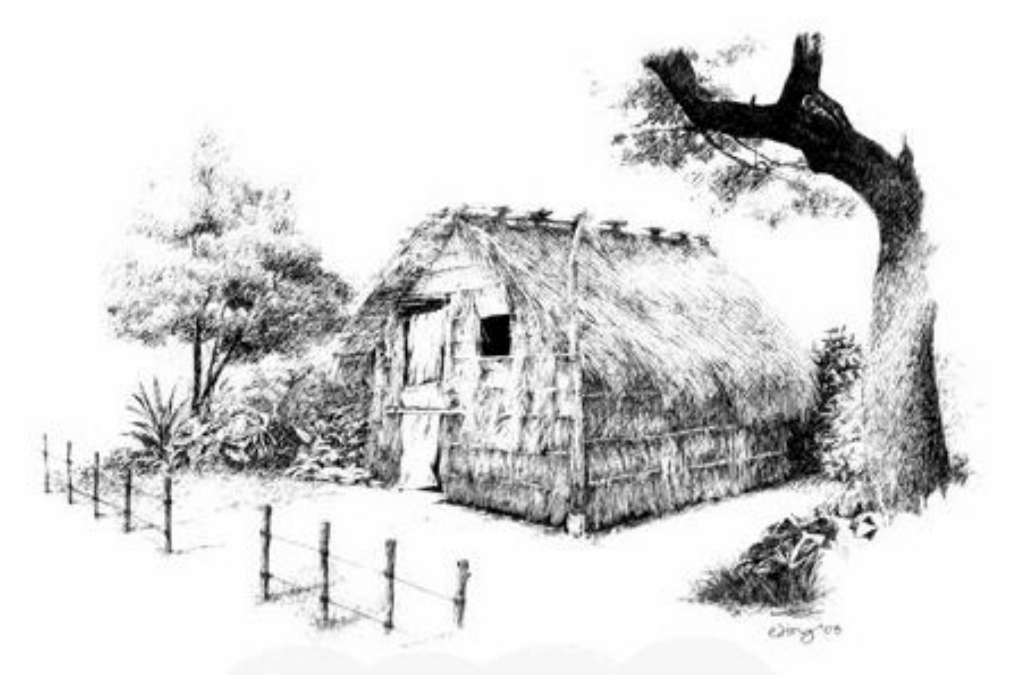
Illus. 3. The “*Chivuvuhung*” House

It may or may not have a wood floor depending on its use and the availability of wood planks. Though it is commonly used as a temporary shelter, there are those who maintain this type of house as a permanent dwelling. As such, a wood floor is a necessity.

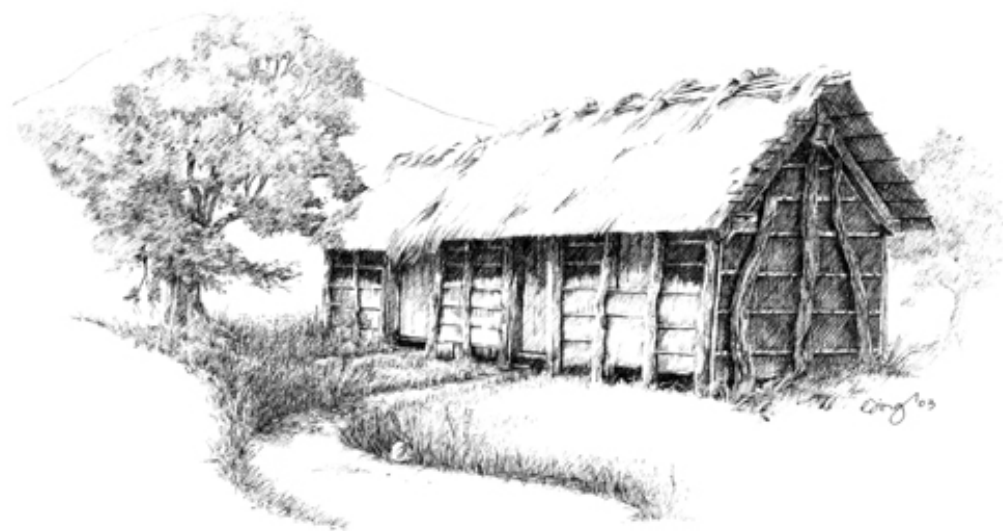
Illus. 4. The “*Jinjin*” House

*Jinjin's* are primarily used as a seasonal shelter in fishing villages such as *Diura* Village in *Batan* Island. These houses provide refuge and sometimes serve as storage where smoked fish are cured during fishing season. They are left unoccupied when the tenants return to the mainland until the next fishing season starts.

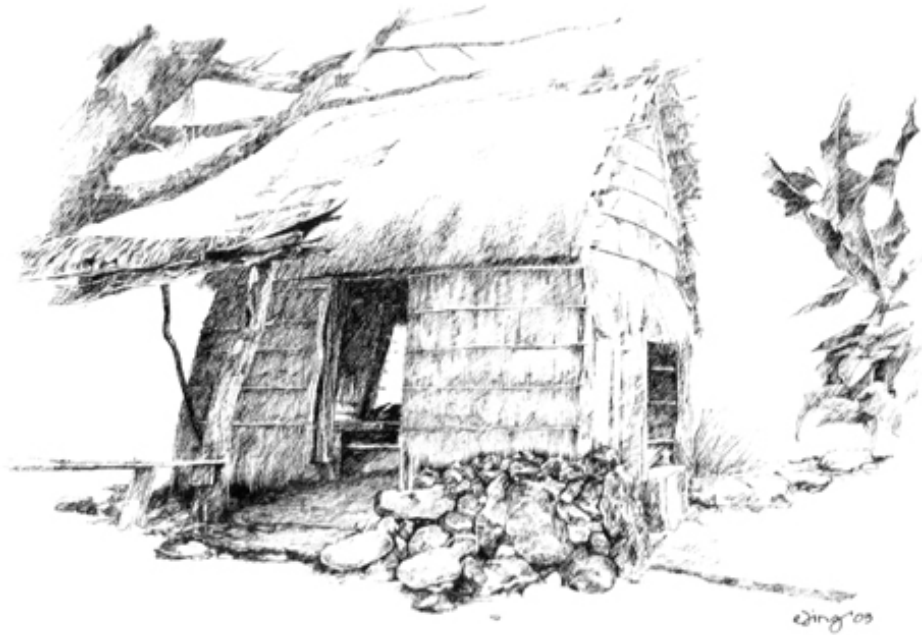
**Illus. 5. The *Mayhuraed* House**

This house type is the next step in the improvement of the *Jinjin* and the *Niriñdiñ*. Since both house types are built at ground level, the damp earth causes problems at the portions close to the ground. The cogon and wood rot faster when in contact with the damp soil. Therefore, a low base consisting of mud and stone is integrated at the lower section of the wall. This base is called *hurahed*. Thus the name *Mayhurahed* or *may hurahed*, meaning “with stone base”.

The stone base serves a more important function during rains. For houses that are built on terrains with uneven slope, the water flowing from the higher areas tend to seep into the floor especially during heavy downpours. The stone base helps divert the water around the house.

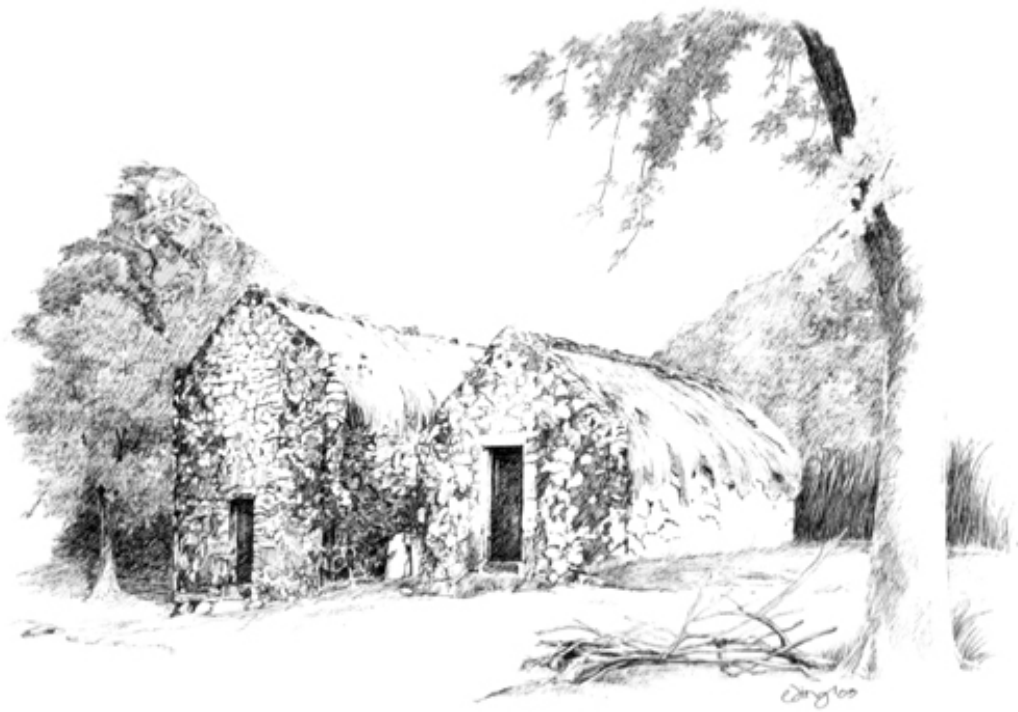
Illus. 6. The “*Sinadumparan*” House

A *Sinadumparan* used as a kitchen is a smaller version of the main house with a few noticeable alterations. Its lower level (basement) is only about a meter high and sometimes, the lower level may be omitted. It is intended mainly as a shelter for small animals such as dogs and fowls. Consequently, the openings in this level are devoid of any door panels. The kitchen has the same door assembly as the main house but has smaller windows, measuring only about half the height of the door.

The most distinguishing feature of the kitchen is a very low wall platform serving as a built-in stove called *rapuyan*. This is also made of stone and mortar. It is also equipped with wooden partitions located above the stove called *paya*, which are used as storage for dried fish, vegetables, condiments, and the like. Wood branches shaped as hangers are hung from the roof truss and above the kitchen's cooking area. Meat and dried fish are hung on these food hangers so that the rations are naturally smoked while cooking. Recessing part of the wall about half a meter deep makes a built-in storage area. This area is just about half a meter wide and a meter tall.

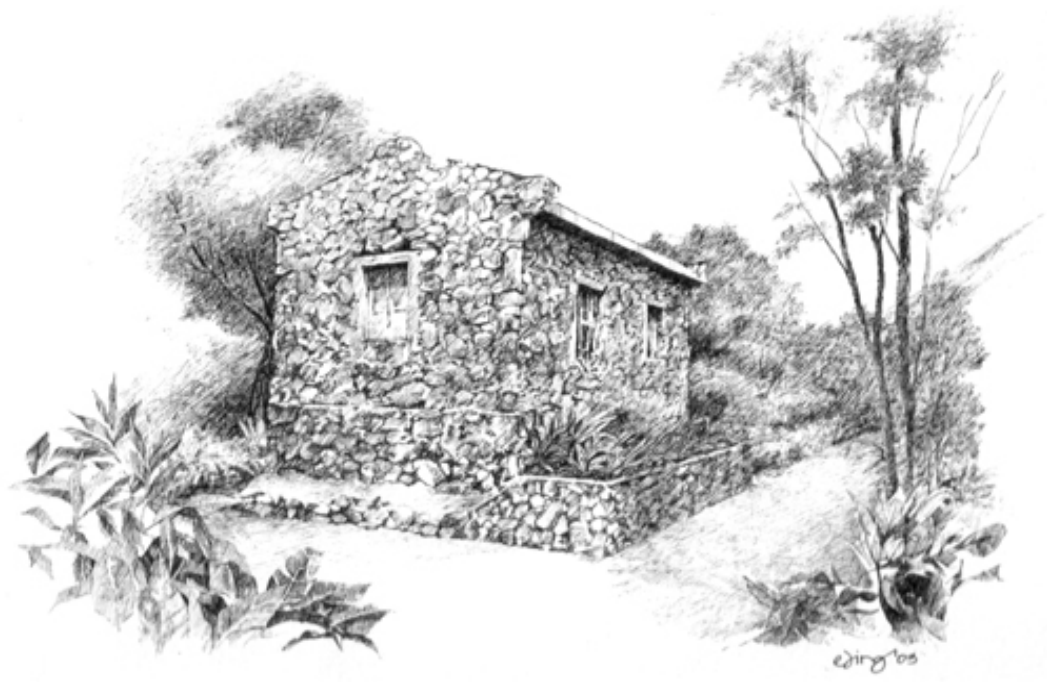
This variation has modifications to the triangular wall. The three corners of the triangle are extended to create wall protrusions with the one at the apex being rectangular in shape resembling a

crown. These serve as flashings meant to protect the cogon roof ridge and the eaves, which are prone to shredding caused by strong winds and rain.

**Illus. 7. Variation of the *Sinadumparan*'s Triangular Wall, referred to as *Sinadumparan* with Crown**

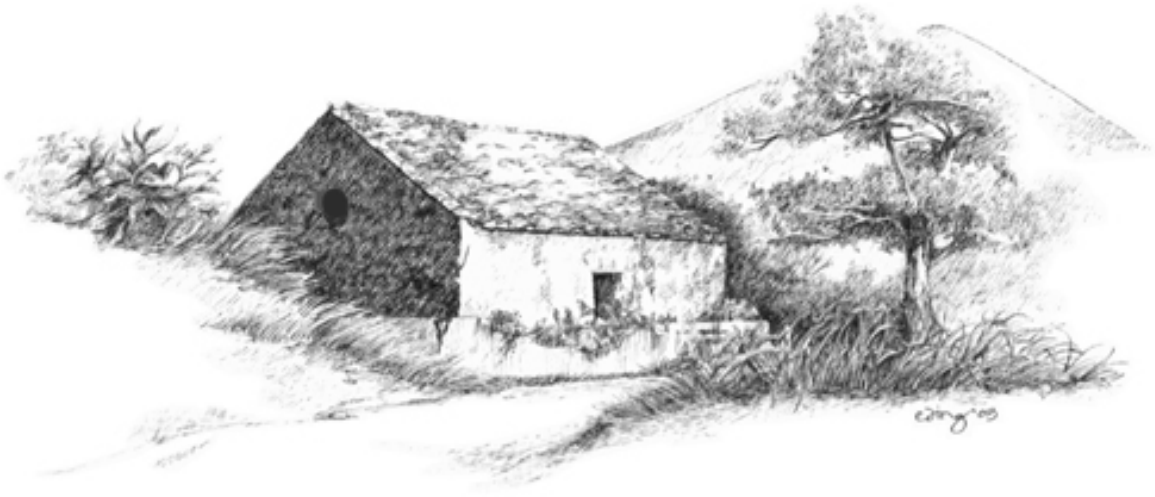
**Illus. 9. The “*Beaterio*” House**

This house type is comparable in form with the *Sinadumparan* minus the lower level and the wooden floor. The most obvious change is the use of clay tile roofing in place of cogon. It was a product of the Spanish regime to introduce clay tiles as a substitute for *cogon* grass. According to local information, only one of these structures was ever built. It is located in the Island of *Batan* and was originally used as a Nun's Convent. To date, it is used as a storage area for the church.

The clay roof tiles are said to have been imported from Spain during the colonization. The house is located conveniently along the main road and close to the sea shore. A unique feature of this structure is the circular windows along the triangulated wall. One window faces the sea and the other faces the church. Niches along the walls of the interior space are used as altars for religious statues.

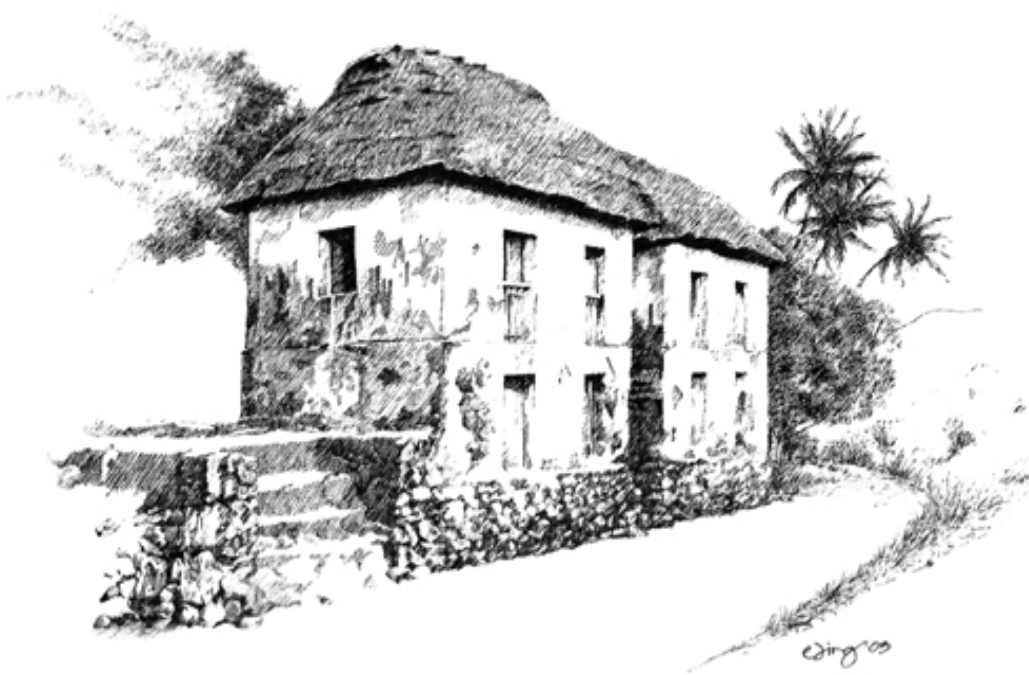
**Illus. 10. The “*Maytuab*” House**

This house type evolved from the *Sinadumparan* (2-slope roof structure) as a result of a disastrous earthquake of 1918 wherein the weak triangular portion of the walls collapsed for some houses. Instead of rebuilding the damaged walls, the 4-slope roof was introduced.

The elimination of the triangular wall resulted in a more structurally sound shell, which eventually led to the construction of taller houses.

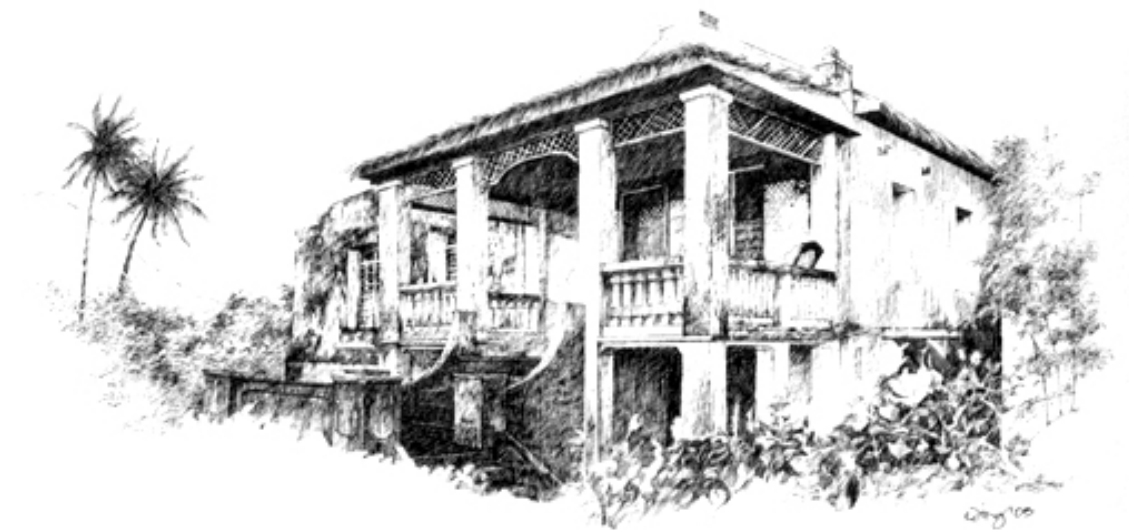
**Illus. 11. The Large Colonial Houses**

In time, colonial houses with two levels and larger spaces emerged during late 19<sup>th</sup> to early 20<sup>th</sup> Century. By osmosis, these houses adapted styles coming from the mainland. The forms developed from the convergence between Native culture and European culture. Styles in *Batanes* evolved into an architectural fusion similar to the famous *bahay na bato* (stone houses) and the churches of other provincial towns seen in the mainland. The combination of Native and Spanish styles is referred to in the Philippines as *arquitectura mestiza*. These developments in *Ivatan* architecture is shaped by construction, technology, and the owners improved lifestyle. In addition, a strong feature of these colonial houses reflects the Filipino’s love for festivities. A large veranda or balcony exists at the entrance foyer where people can view religious processions and parades held yearly during town fiestas. Larger kitchens, receiving and dining areas are evident in interior spaces to accommodate visitors during these celebrations.

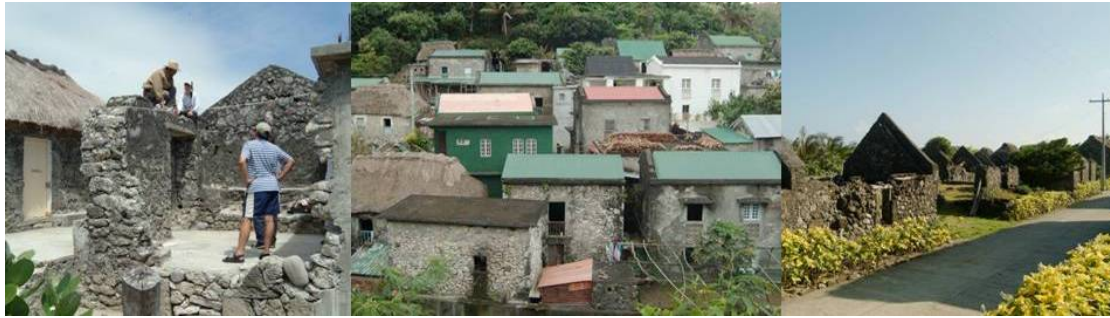
**Fig. 25 to 27 - Damage and Changes in the Use of Materials**

Some villages are gradually being infused with changes. Some houses of stone and lime with thatch roof are shifting to new materials. The corners of the houses would now present themselves with concrete columns, while the grass roofs have slowly been replaced with corrugated galvanized iron sheets imported from the mainland. The houses originally with stone beams would now be seen with reinforced concrete structural members. Even the stone lintel that holds the upper structural part of the apertures of the houses would slowly disappear and be converted to concrete lintel beams, infused with reinforcing bars.

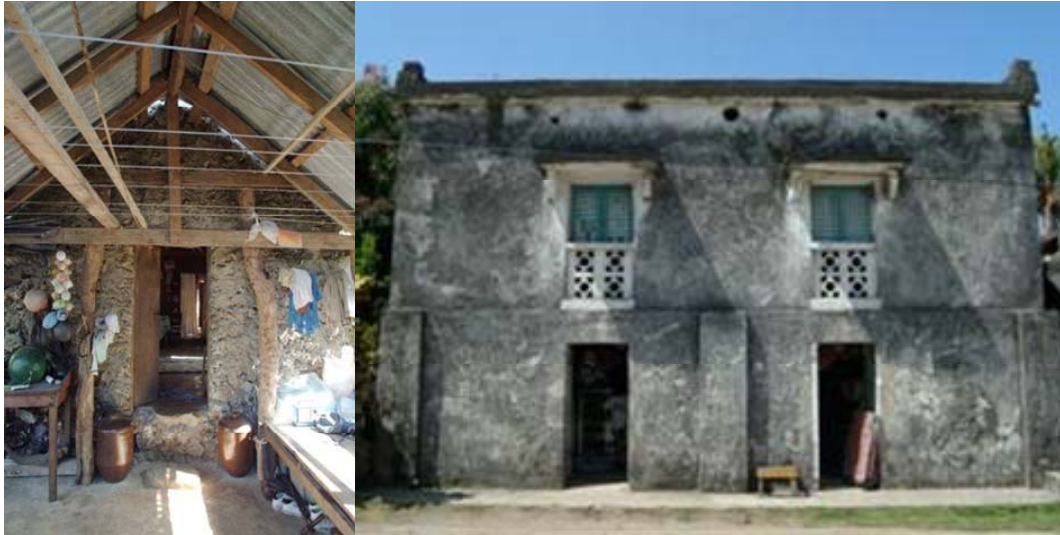
Fig. 28 & 29 Examples of Changes in Roofing Materials
